Home Inspection Report

Prepared for: James Riddle
Inspection #: 202506-61052
Inspection Address: 1113 Kayla Lane
Townsend DE 19734

Inspection Company: **Amerispec**
Office: 302-996-0405
Inspector: Clay Ballard Lic # DE H4-0010250

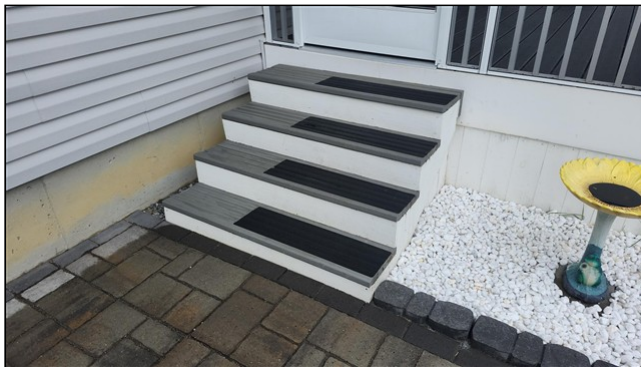
1.2 Item 1 (Picture)

No hand railings noted on steps at rear of home, recommend installing to ensure safety. When ever three or more steps are present a handrail is usually required.

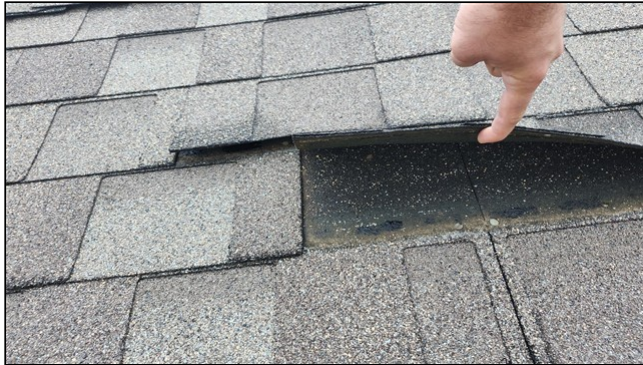
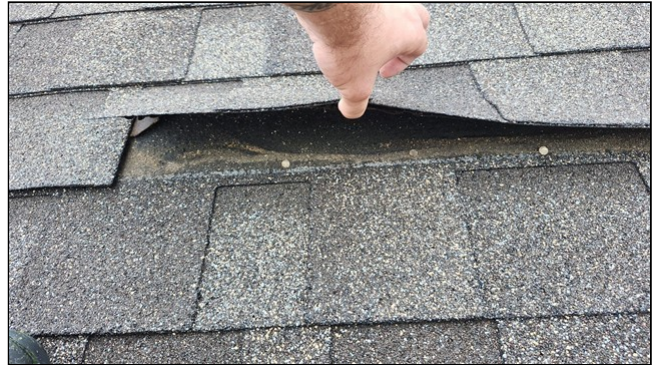
Not all shingles are adhered in place (multiple locations) which may result in wind damage, recommend correcting to prevent leakage.

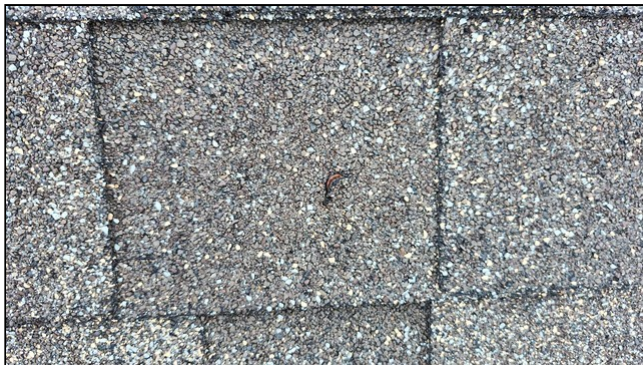
3.0 Item 3 (Picture)

Nails have penetrated through the shingles at rear of the home. Recommend repairs to correct this condition to prevent leakage.

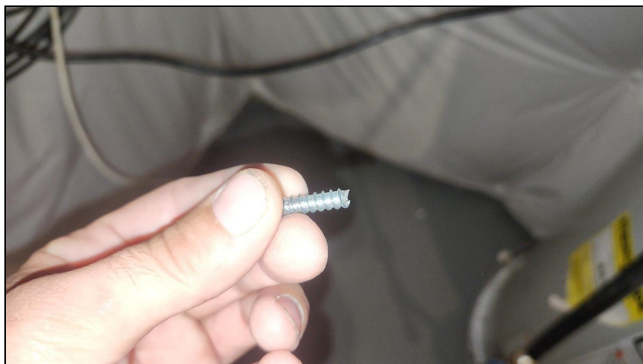
6.2 Item 1 (Picture)

Pointed sheet metal screws have been used to secure the dead front cover to the front of the main panel. This is a potential shock hazard. Blunt screws should be used to prevent the wire insulation from being cut by the screws.

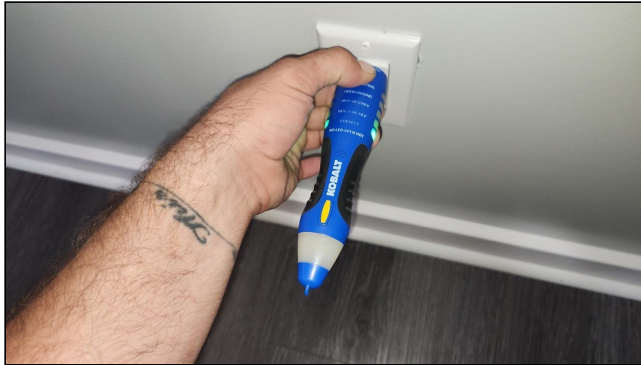
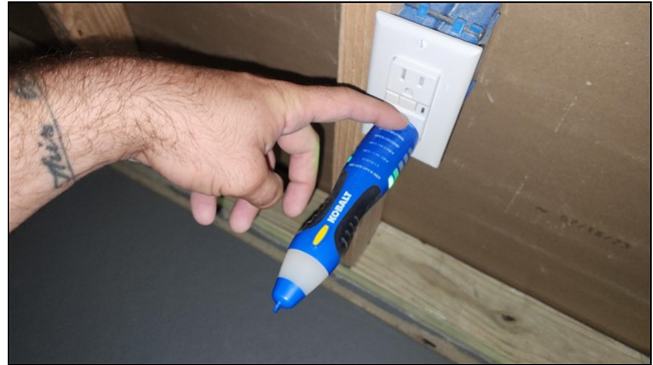
GFCIs at basement (finished) did not trip when tested (defective). Recommend repair / replacement as needed for safety.

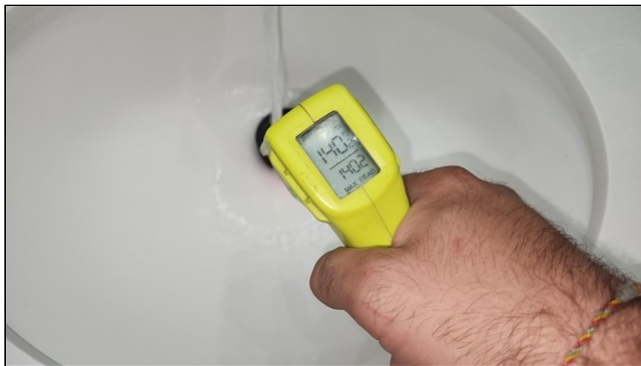
10.1 Item 1 (Picture)

The water temperature at time of inspection was 140 degrees, which is above the normal operating range of 120 to 125 degrees. This is a safety concern. Recommend lowering temperature to prevent scalding.

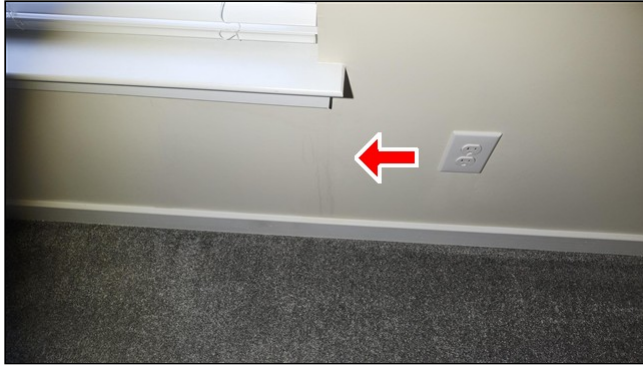
14.4 Item 1 (Picture)

Moisture stains at front left most bedroom indicate prior leakage. Stains test dry at time of inspection. Inspector could not determine if water penetration has been resolved.

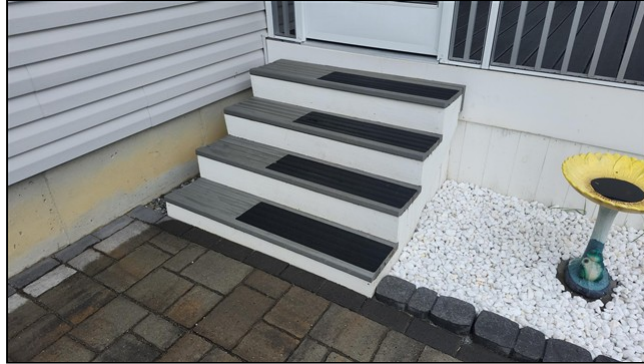
1.2 Item 1 (Picture)

No hand railings noted on steps at rear of home, recommend installing to ensure safety. When ever three or more steps are present a handrail is usually required.

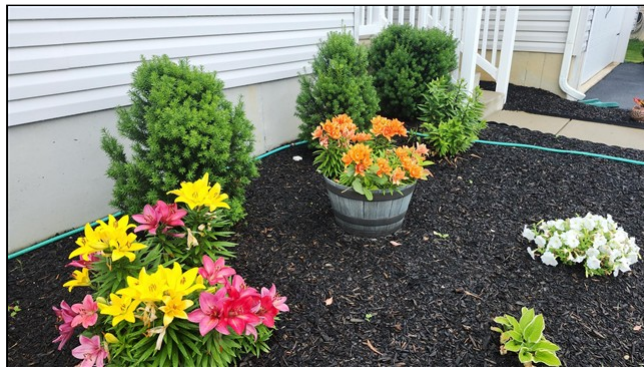
1.3 Item 1 (Picture)

Trimming and/or removal of vegetation / trees away from the structure is recommended as overgrowth can promote moisture damage and / or pest infiltration.

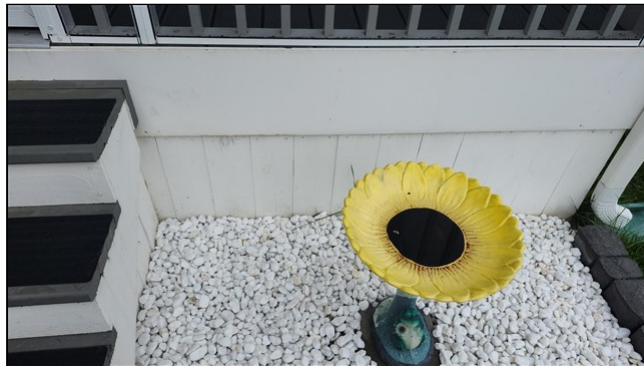
1.5 Item 1 (Picture)

Unable to view beneath deck due to lattice or skirting.

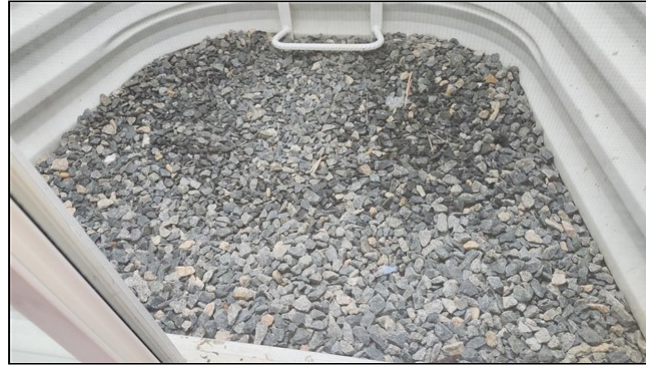
1.7 Item 1 (Picture)

Drains missing (not visible). Recommend installing to prevent water from collecting in well which could allow water to penetrate through the window.

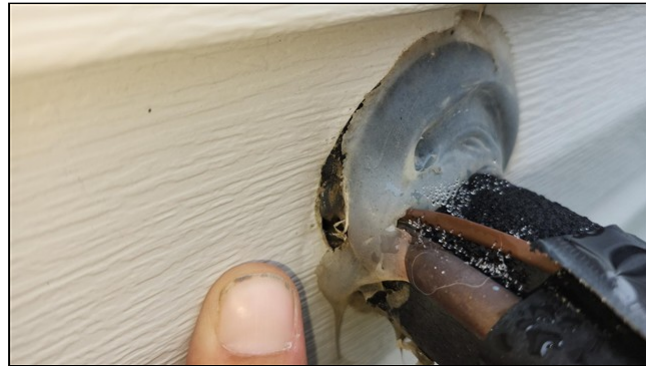
1.8 Item 1 (Picture)

Caulking gaps at service penetration and trim joints is recommended to prevent water penetration / damage.

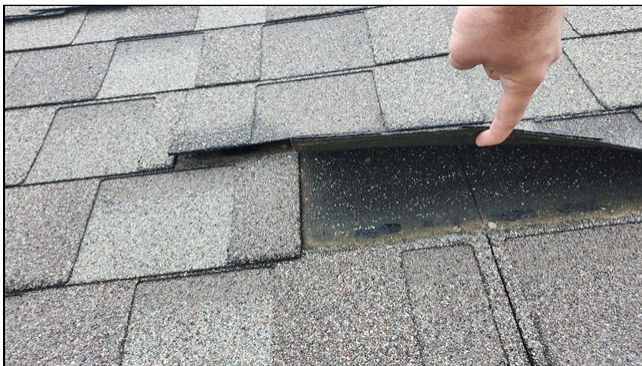
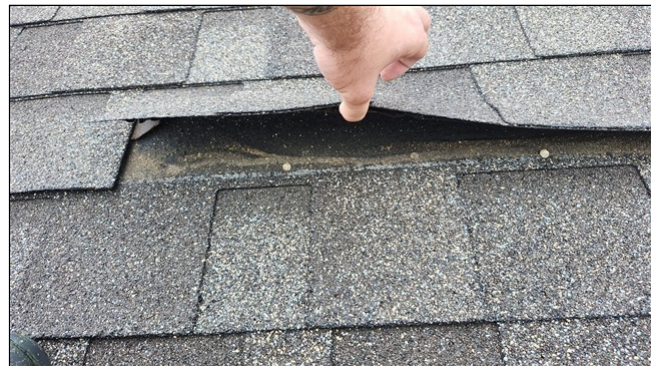
Not all shingles are adhered in place (multiple locations) which may result in wind damage, recommend correcting to prevent leakage.

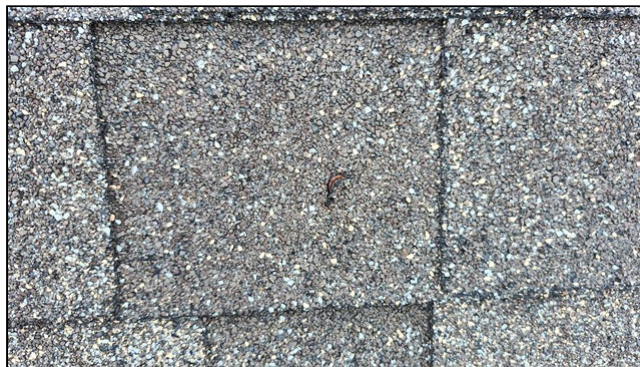
3.0 Item 3 (Picture)

Nails have penetrated through the shingles at rear of the home. Recommend repairs to correct this condition to prevent leakage.

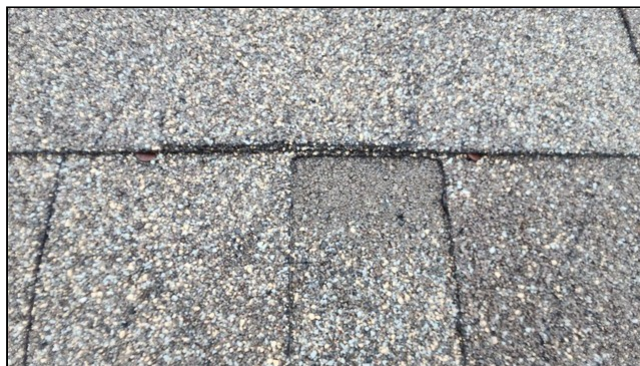
3.0 Item 4 (Picture)

Nails are not sealed at cap shingles at various locations. Nail heads should be sealed to prevent water penetration as a part of routine maintenance.

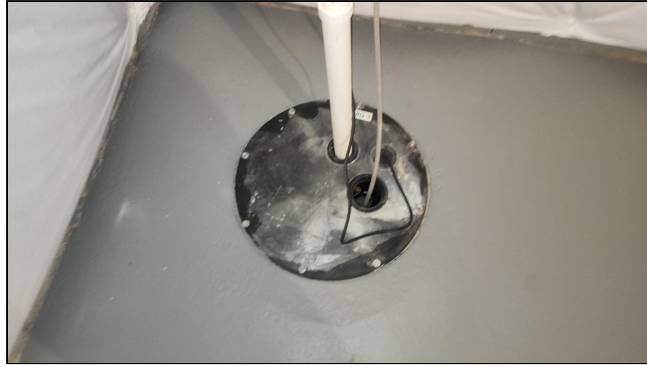
5.8 Item 1 (Picture)

The crock is sealed. Not tested.

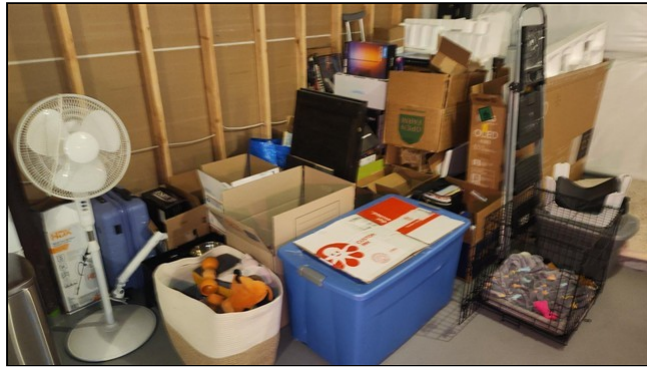
5.10 Item 1 (Picture)

Limited view due to stored items.

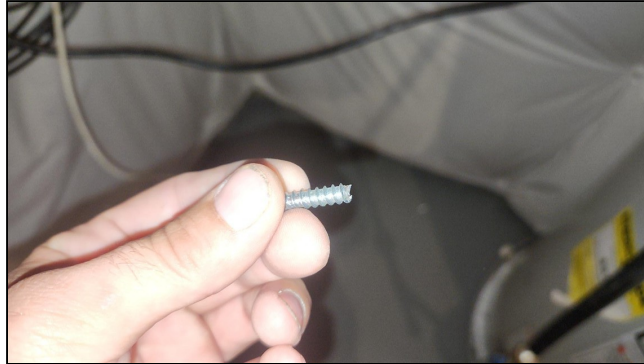
6.2 Item 1 (Picture)

Pointed sheet metal screws have been used to secure the dead front cover to the front of the main panel. This is a potential shock hazard. Blunt screws should be used to prevent the wire insulation from being cut by the screws.

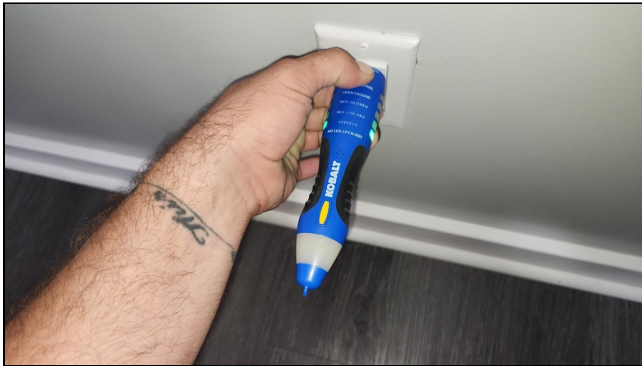
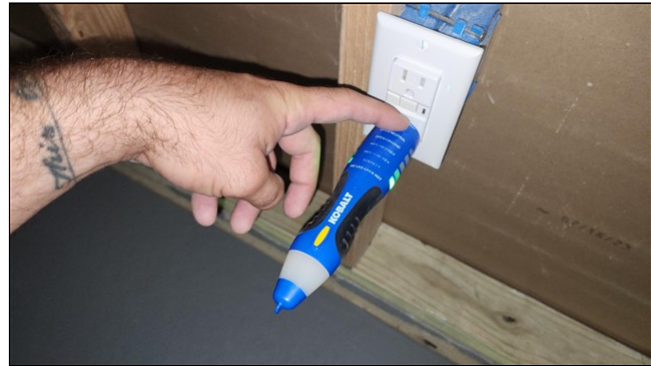
GFCIs at basement (finished) did not trip when tested (defective). Recommend repair / replacement as needed for safety.

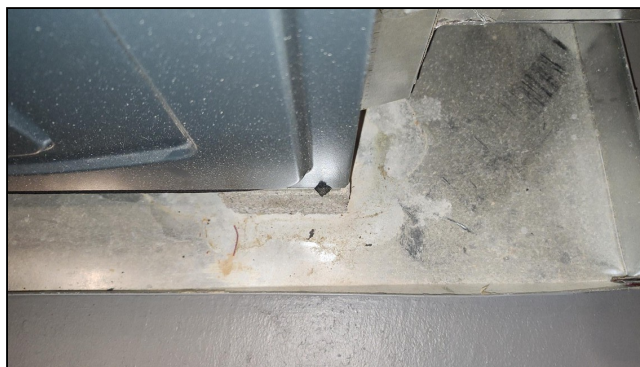
7.9 Item 1 (Picture)

staining present in furnace pan.

Recommend confirming condensation isn't an ongoing issue.

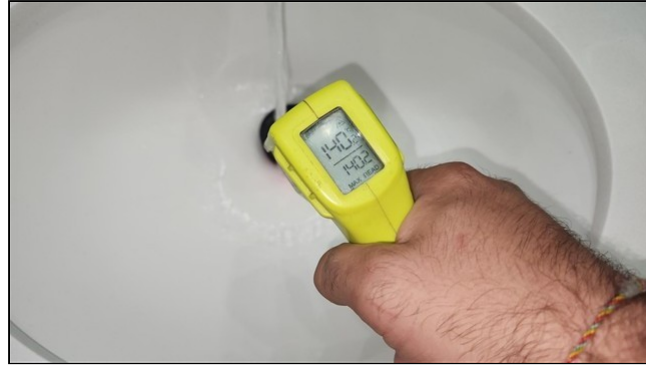
10.1 Item 1 (Picture)

The water temperature at time of inspection was 140 degrees, which is above the normal operating range of 120 to 125 degrees. This is a safety concern. Recommend lowering temperature to prevent scalding.

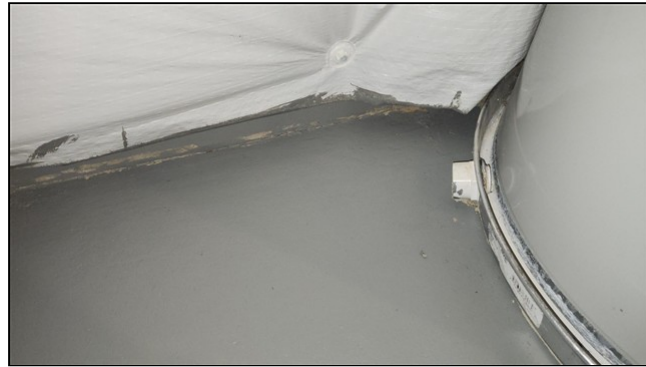
10.6 Item 1 (Picture)

Drain line missing / not run to exterior / french drain. Recommend correcting for proper operation of emergency feature.

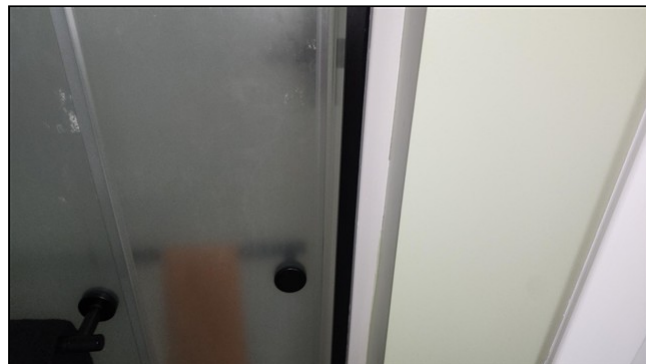
12.3 Item 1 (Picture)

Shower door in the basement does not fully shut. Recommend repairs as needed.

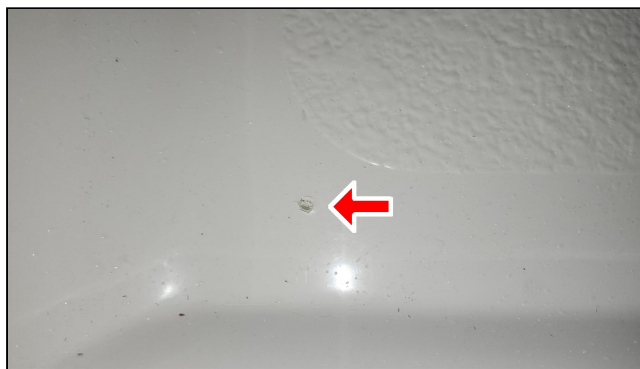
12.3 Item 2 (Picture)

Cracked/chipped in the shared bathroom, no leaks observed. Recommend consulting seller as to usage history and leak free conditions.

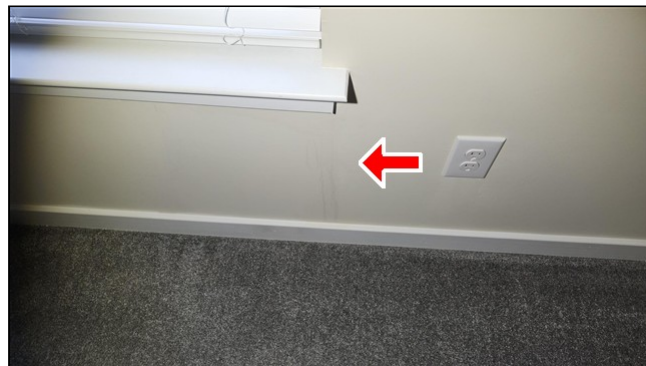
14.4 Item 1 (Picture)

Moisture stains at front left most bedroom indicate prior leakage. Stains test dry at time of inspection. Inspector could not determine if water penetration has been resolved.

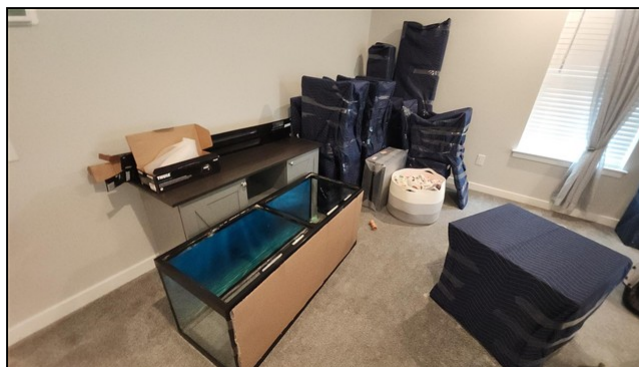
14.5 Item 1 (Picture)

Limited review at various locations due to personal property.
