## Home Inspection Report

Prepared for: Archie c/o James Riddle  
Inspection #: 202512-62329  
Inspection Address: 3231 Williamsville Road,  
Houston DE 19954

Inspection Company: **Amerispec**  
Office: 302-996-0405  
Inspector: Rob Graves Lic # DE H4-0010208

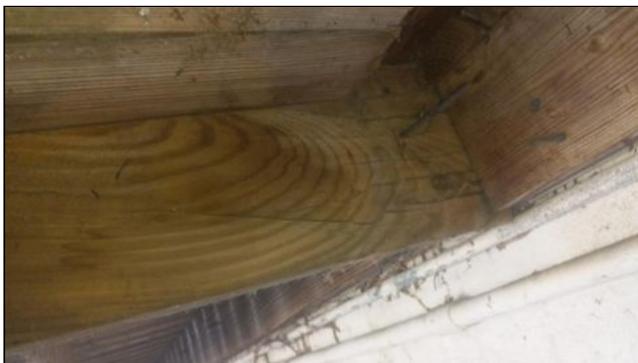
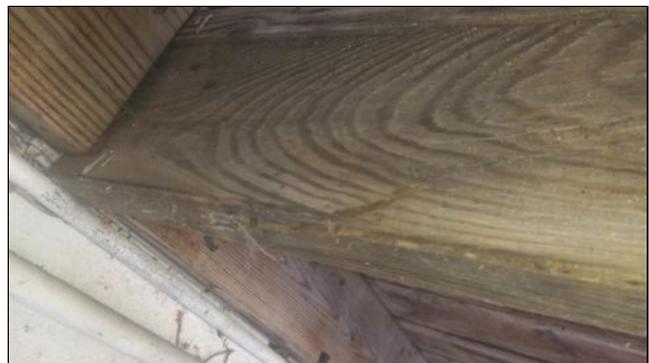
1.6 Item 1 (Picture)

The deck is poorly framed, inadequately supported or over spanned. Recommend repair / replacement as necessary to ensure safety.

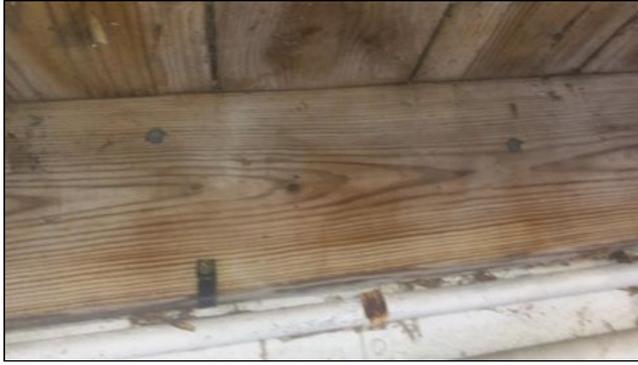
1.6 Item 3 (Picture)

The deck band is not attached properly to the wall or band of the home. It should have 5/8 galvanized "Lag Screws" or "Carriage Bolts" (preferred) approximately every 36 inches. Only nails observed. Recommend correcting to ensure safety.

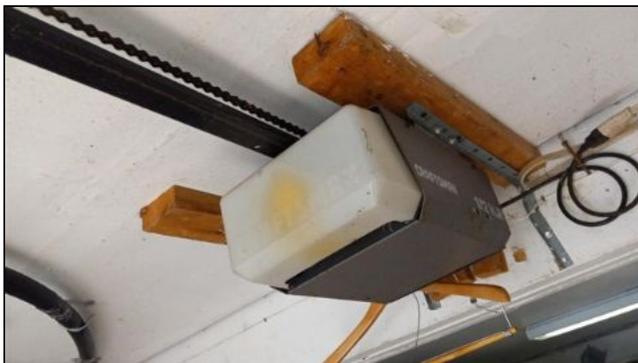
2.1.A Item 1 (Picture)

Door opener is inoperable. Recommend repair / replacement as necessary.

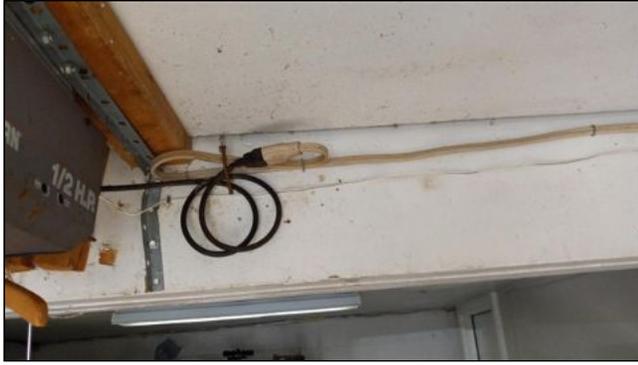
2.1.A Item 2 (Picture)

Door opener is wired with an extension cord. While permanent wiring and receptacles may not have been required when the home was built, ideally garage door openers should be powered by a dedicated receptacle. Client should consider installation of a dedicated receptacle as a safety upgrade.

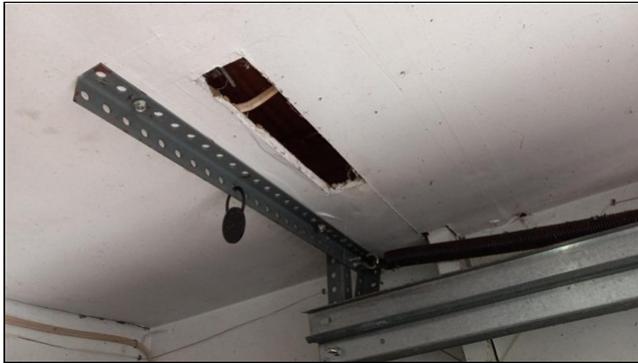
2.4.A Item 1 (Picture)

Fire rating of the garage wall is compromised as a result of holes, cracking, loose drywall tape or thru wall penetrations. This is a safety concern. Recommend repairs as necessary to correct.

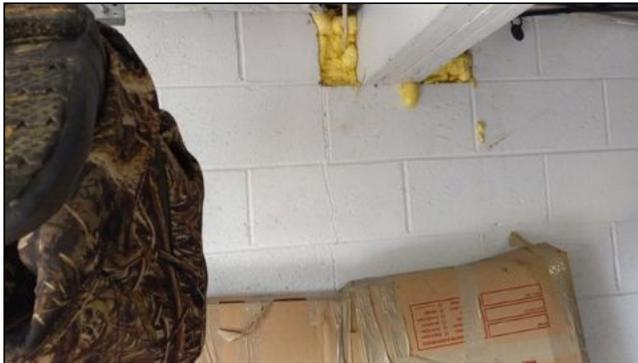
2.5.A Item 1 (Picture)

Larger than normal crack observed at: garage at the beam pocket on the left wall. Crack is inside and out. . Inspector can not determine if this condition has stabilized. Recommend further evaluation by a licensed structural specialist and repairs as necessary.

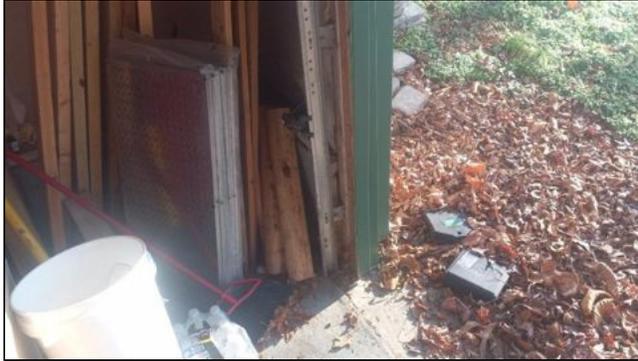
2.1.B Item 1 (Picture)

The electric eyes are mounted too far above the floor to protect small children, pets, or property as intended by the manufacturer. Recommend lowering the eyes to within 6 inches of the floor or manufactures specifications to ensure safety.

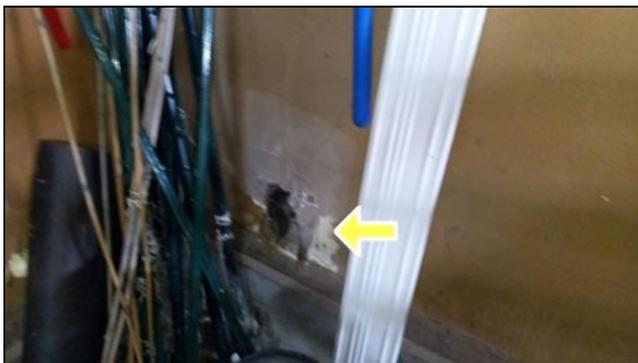
2.6.B Item 1 (Picture)

Drywall is damaged significantly at detached garage . Recommend repair / replacement as necessary.

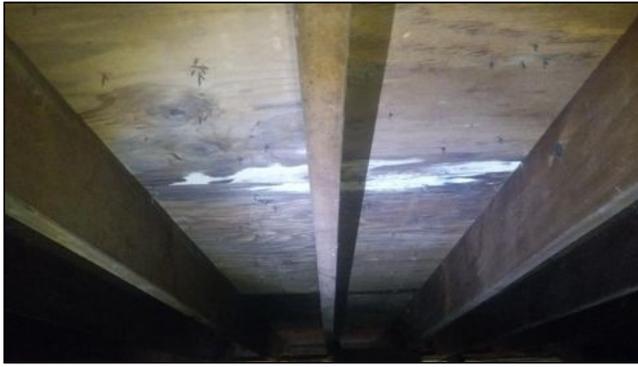
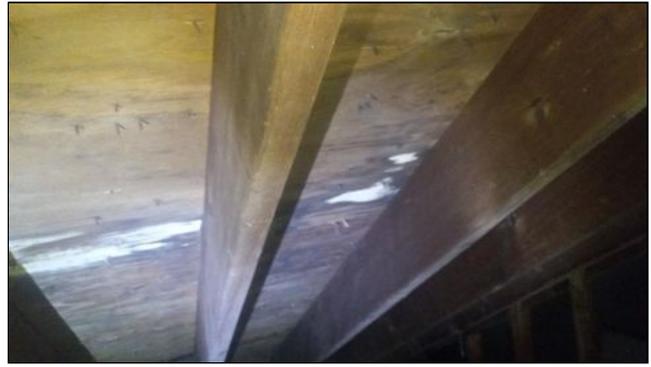
2.7.B Item 1 (Picture)

Possible microbiological growth observed at garage attic . Because certain types of microbiological spores may result in adverse health effects, it is strongly recommended that a microbiological inspection be performed by a qualified licensed professional and that corrective measures be taken to eliminate both microbiological growth and moisture related conditions.

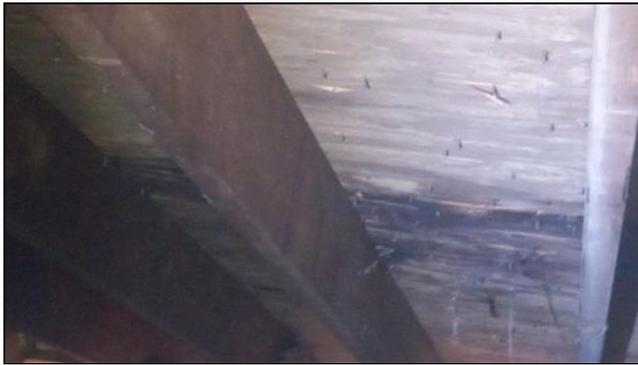
2.7.B Item 3 (Picture)

Stains observed in the garage attic . Stain tested dry with a moisture meter at time of inspection. Recommend further review and repairs as needed.

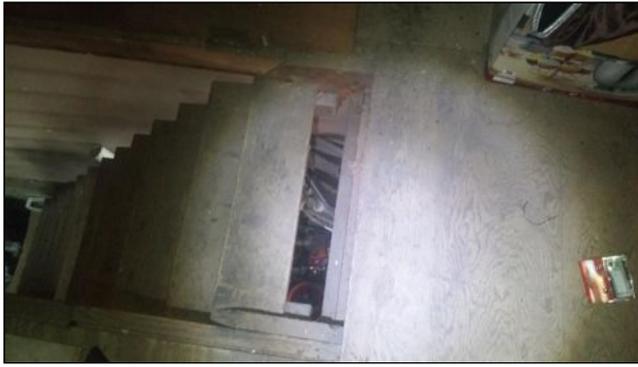
2.9.B Item 1 (Picture)

Spacing between open risers at detached garage are greater than 4 inches on stair unit that is *30 inches or higher*. This is considered improper as a 4 inch sphere can penetrate. And there are missing and damaged boards. Recommend repairs / replacement as necessary to ensure safety.

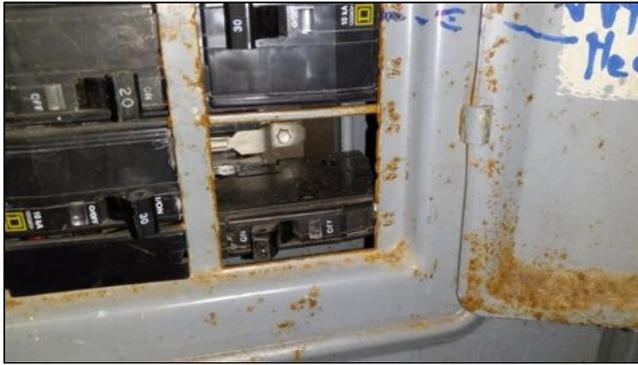
9.2 Item 6 (Picture)

Open knockouts observed in the main panel cover. Recommend installing knockout plugs, as needed, for safety.

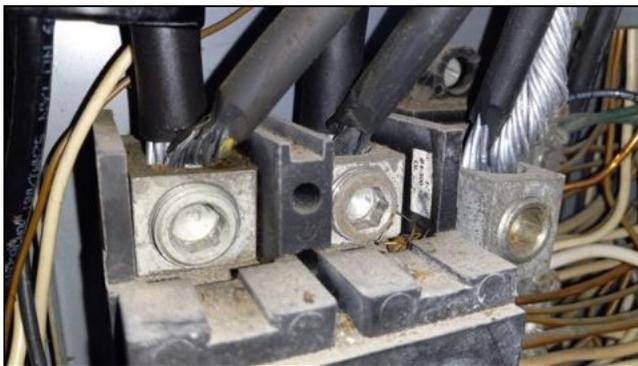
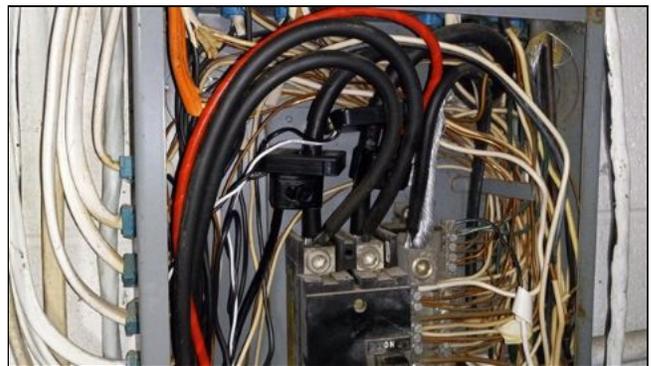
9.2 Item 8 (Picture)

Double tapping observed in the main panel. The 100 amp service for the detached garage is double tapped into the 150 amp service lugs. Double tapping (i.e. 2 wires on a single pole breaker) can add to the load of the affected circuit causing a possible overload and tripping breakers. Recommend repair / replacement as necessary.

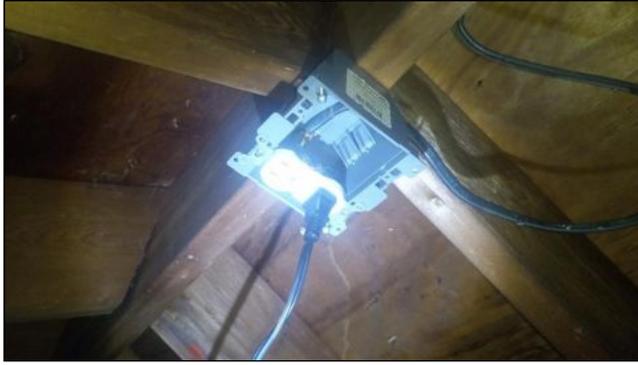
9.9 Item 1 (Picture)

Receptacle cover is missing at garage attic. Recommend replacing to ensure safety.

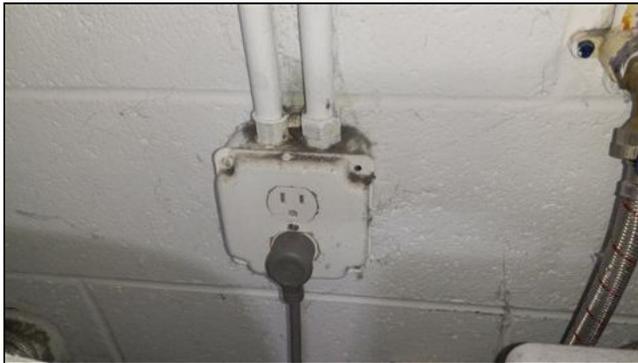
9.9 Item 2 (Picture)

Outlet is mounted directly onto foundation wall without a wood spacer at laundry room and garage which is considered improper. Wood is recommended to be between the foundation wall and the outlet to ensure safety.

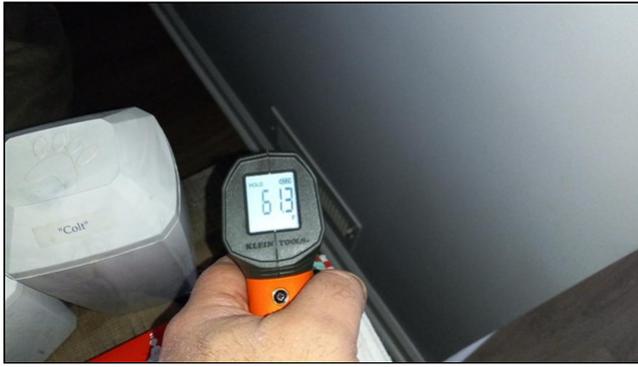
10.1.A Item 1 (Picture)

The emergency back up heat was tested and found NOT to be serviceable with a supply temperature of 61 degrees which is NOT within the normal operating range of 90 - 120 degrees.

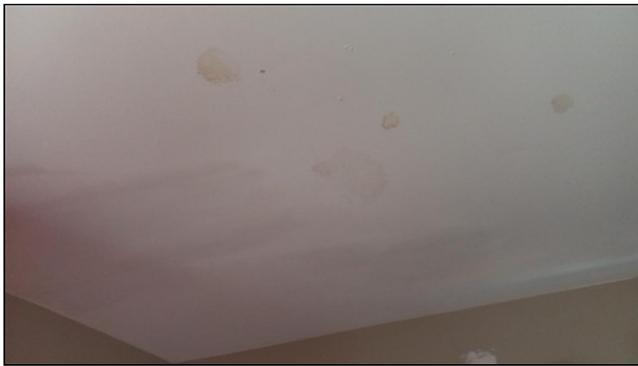
17.2 Item 1 (Picture)

Stains observed in the master bedroom . Stain tested dry with a moisture meter at time of inspection. Recommend further review and repairs as needed.

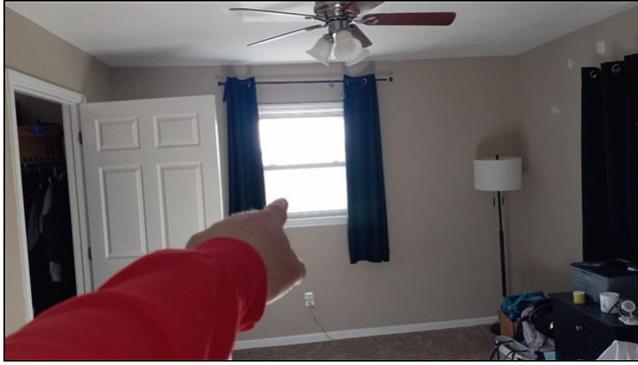
17.4 Item 1 (Picture)

Observed both sash wires/cords broken at master bedroom . This is a "Safety Concern". Sash wire/cord holds window in open position. Suggest repairs / replacement as needed to ensure safety.

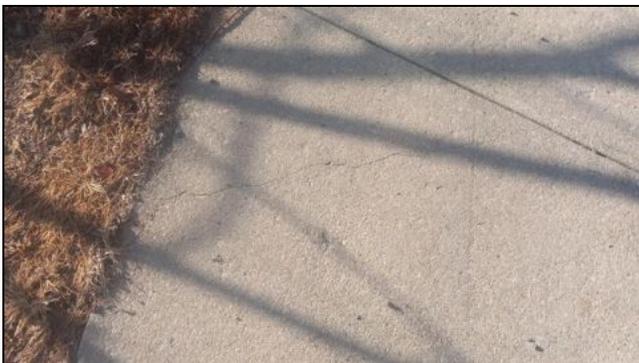
1.1 Item 1 (Picture)

Common cracks observed, primarily a cosmetic concern. We suggest sealing all cracks in surfaces to prevent water penetration as a routine maintenance effort.

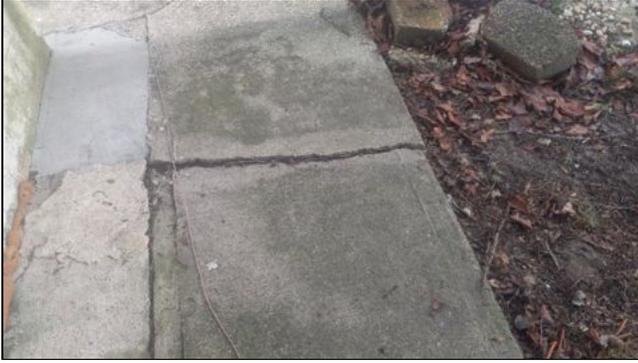
1.1 Item 3 (Picture)

Raised/settled areas are a potential trip hazard. We suggest repair/replacement as needed to enhance safety.

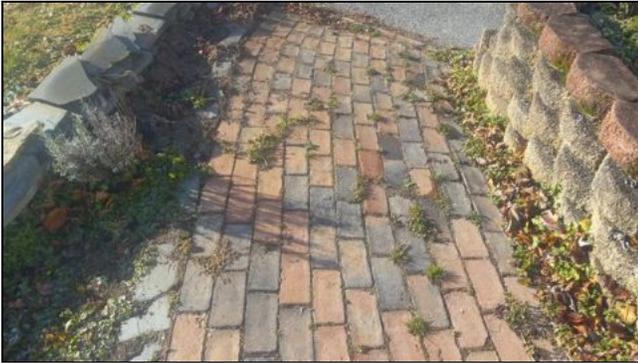
1.2 Item 1 (Picture)

Settlement / rotation noted at front which is a potential trip hazard. Recommend patching / repairing to improve safety.

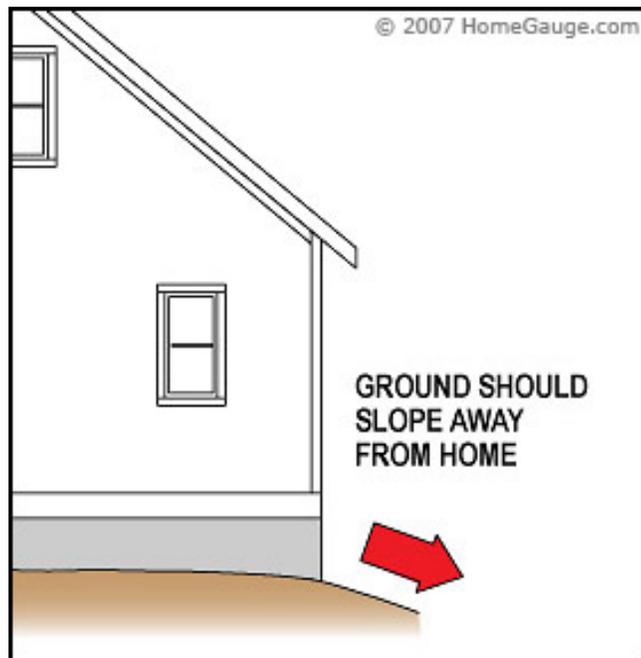
1.3 Item 1 (Picture) Lot Pitch

Recommend adding dirt back-fill to any low lying areas around the foundation to ensure proper drainage away from the foundation at all times. Slope should fall away from the foundation at a minimum of 1/2 inch per foot and extend at least 10 feet away from the foundation.

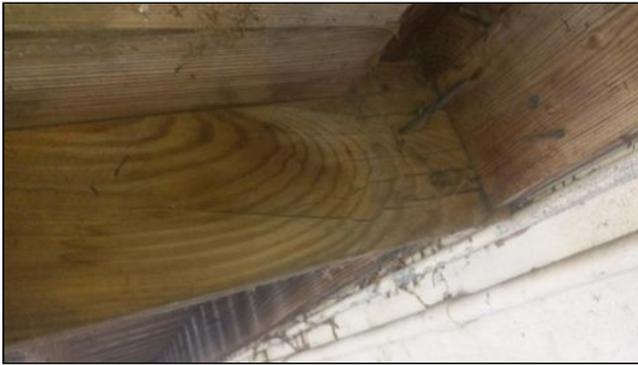
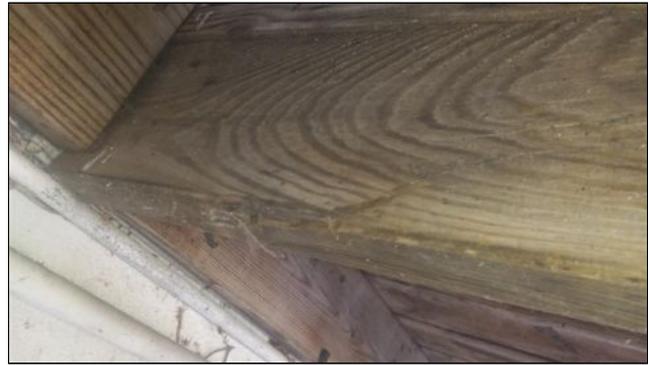
1.6 Item 1 (Picture)

The deck is poorly framed, inadequately supported or over spanned. Recommend repair / replacement as necessary to ensure safety.

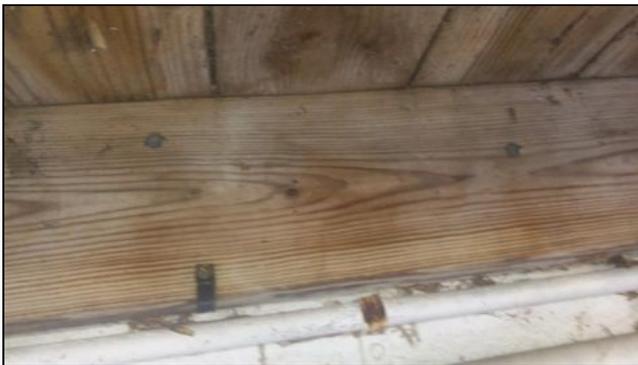
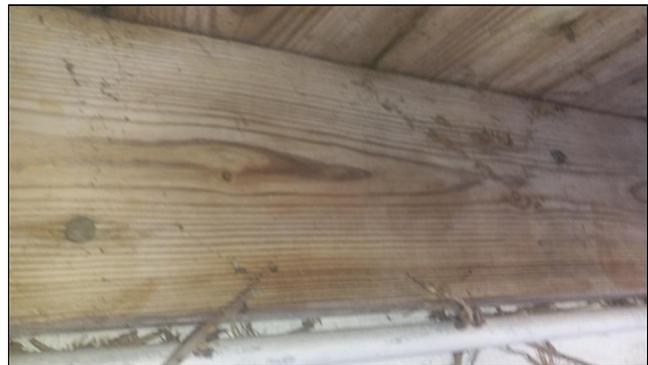
1.6 Item 3 (Picture)

The deck band is not attached properly to the wall or band of the home. It should have 5/8 galvanized "Lag Screws" or "Carriage Bolts" (preferred) approximately every 36 inches. Only nails observed. Recommend correcting to ensure safety.

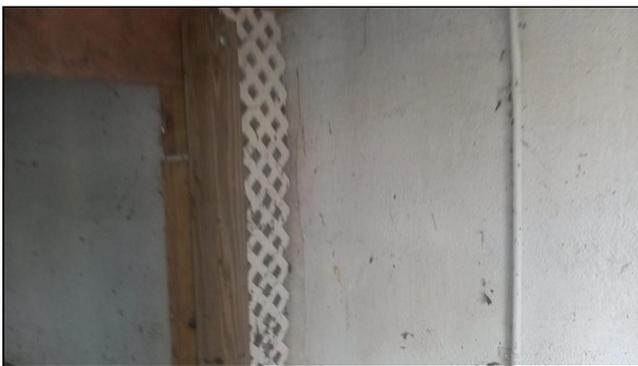
1.7 Item 1 (Picture)

Common cracks observed, primarily a cosmetic concern. Suggest sealing to prevent water penetration as a routine maintenance effort.

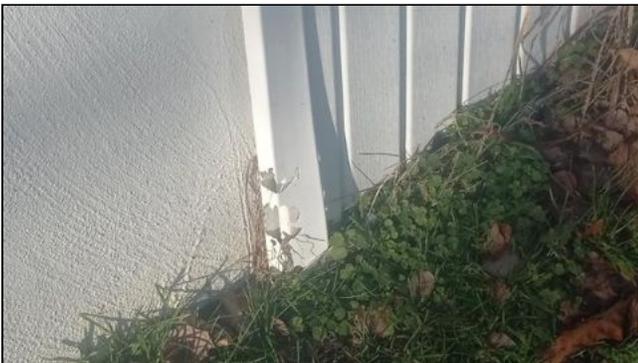
1.9 Item 1 (Picture)

Damaged and/or missing siding observed at: various locations . Recommend repair / replacement as necessary.

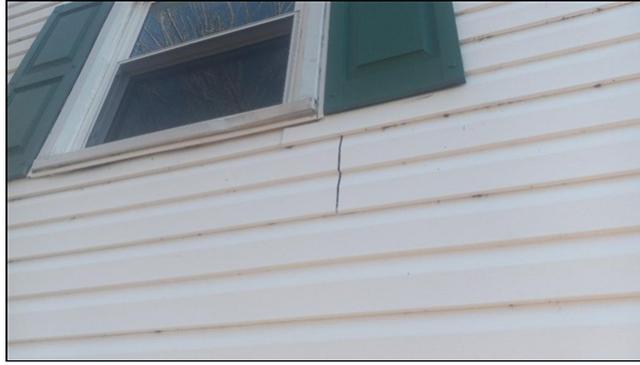
1.9 Item 3 (Picture)

Gap observed at left side recommend correcting to prevent water / pest intrusion.

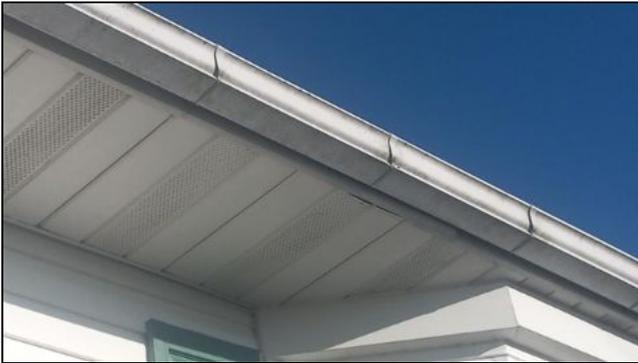
1.10 Item 1 (Picture)

Loose / missing trim pieces observed at front. Recommend repair / replacement as necessary.

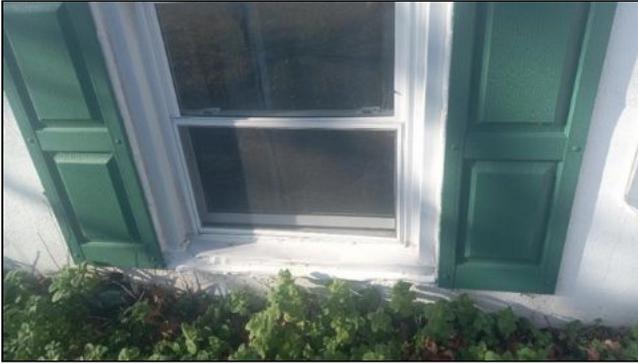
1.10 Item 4 (Picture)

This is an older home. Aluminum wrapped trim appears to have been installed over previously exposed wood trim. Hidden damage may exist. Recommend consulting seller for further details regarding history of sill conditions.

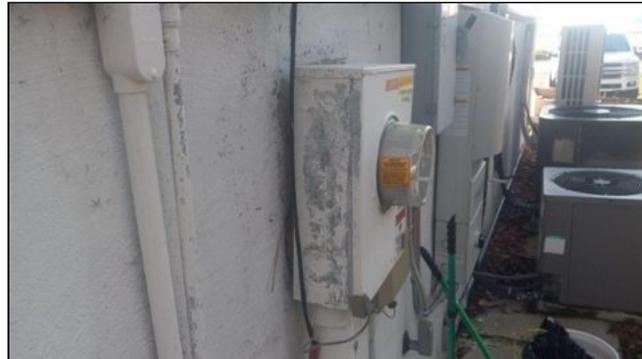
1.14 Item 1 (Picture)

The meter is loosely attached to the structure. Recommend utility company evaluate and correct as necessary.

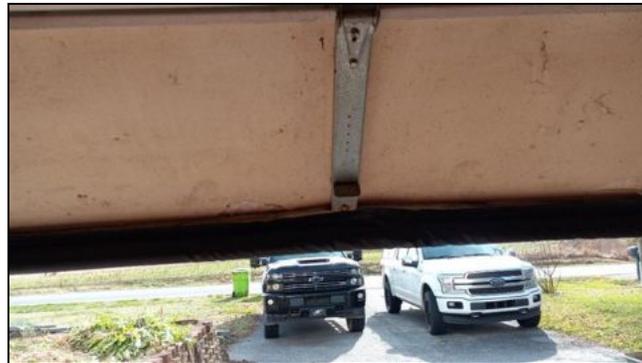
2.0.A Item 1 (Picture)

The door panel of the garage door is bent. Recommend repair as necessary to help assure long term serviceability.

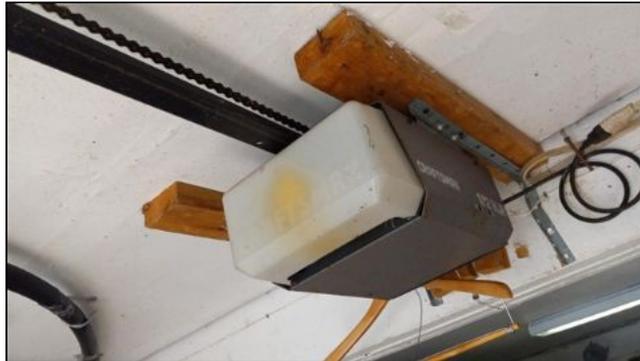
2.1.A Item 1 (Picture)

Door opener is inoperable. Recommend repair / replacement as necessary.

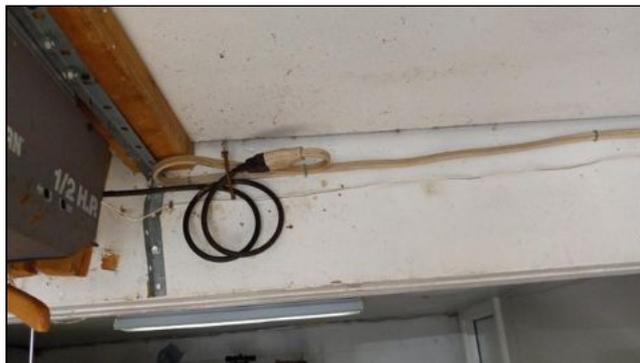
2.1.A Item 2 (Picture)

Door opener is wired with an extension cord. While permanent wiring and receptacles may not have been required when the home was built, ideally garage door openers should be powered by a dedicated receptacle. Client should consider installation of a dedicated receptacle as a safety upgrade.

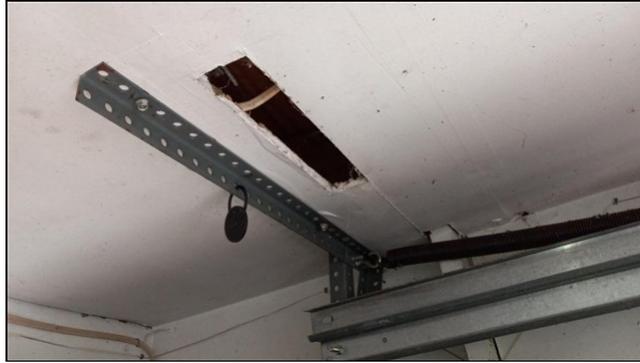
2.4.A Item 1 (Picture)

Fire rating of the garage wall is compromised as a result of holes, cracking, loose drywall tape or thru wall penetrations. This is a safety concern. Recommend repairs as necessary to correct.

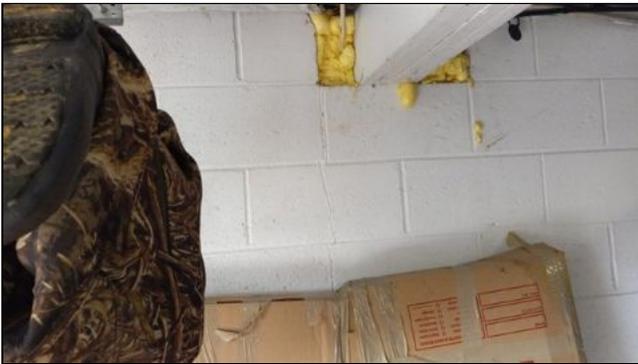
2.5.A Item 1 (Picture)

Larger than normal crack observed at: garage at the beam pocket on the left wall. Crack is inside and out. . Inspector can not determine if this condition has stabilized. Recommend further evaluation by a licensed structural specialist and repairs as necessary.

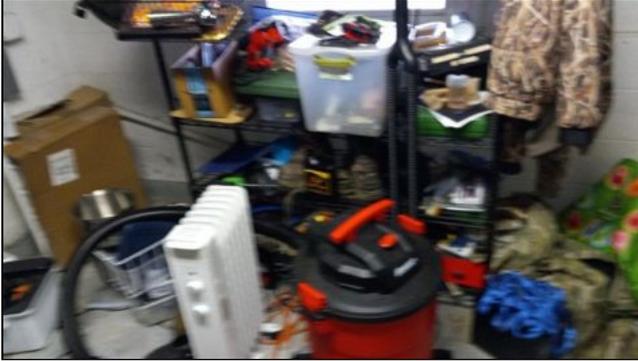
2.16.A Item 1 (Picture)

Limited review of the garage due to personal property.

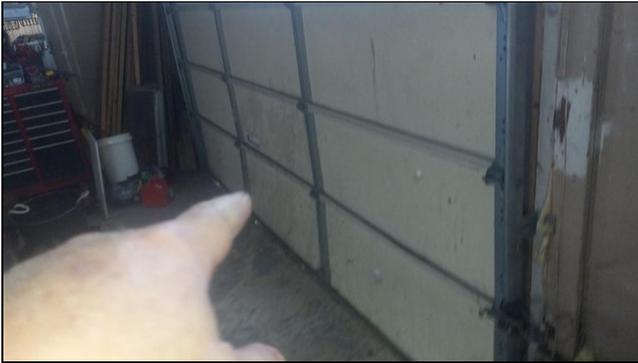
2.0.B Item 1 (Picture)

The door panel of the garage door is bent. Recommend repair as necessary to help assure long term serviceability.

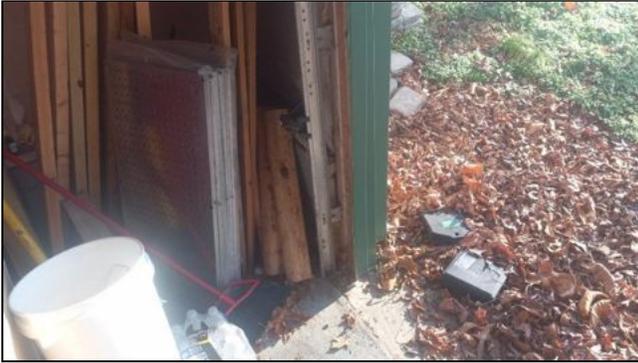
2.1.B Item 1 (Picture)

The electric eyes are mounted too far above the floor to protect small children, pets, or property as intended by the manufacturer. Recommend lowering the eyes to within 6 inches of the floor or manufactures specifications to ensure safety.

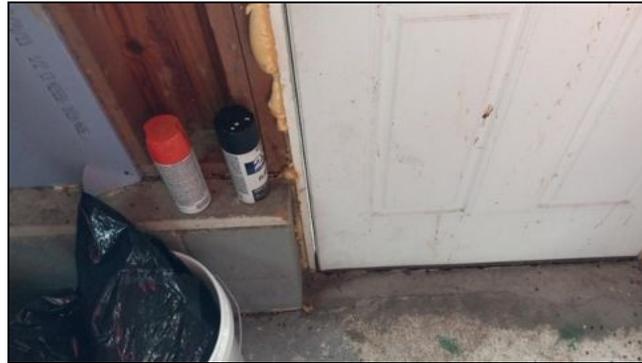
2.2.B Item 1 (Picture)

Damaged/missing weather stripping observed at the garage, repair/replace as needed to prevent water penetration / draft.

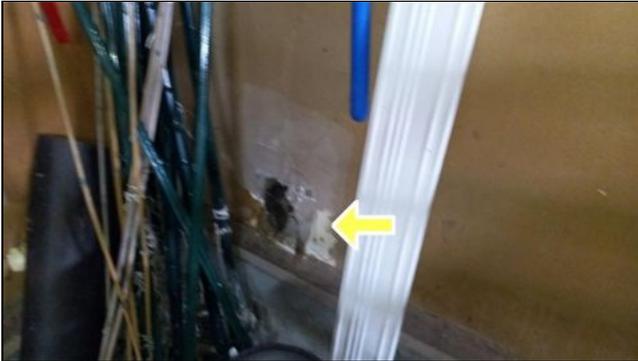
2.6.B Item 1 (Picture)

Drywall is damaged significantly at detached garage . Recommend repair / replacement as necessary.

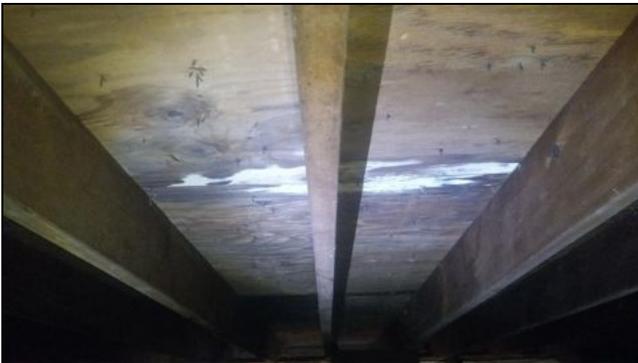
2.7.B Item 1 (Picture)

Possible microbiological growth observed at garage attic . Because certain types of microbiological spores may result in adverse health effects, it is strongly recommended that a microbiological inspection be performed by a qualified licensed professional and that corrective measures be taken to eliminate both microbiological growth and moisture related conditions.

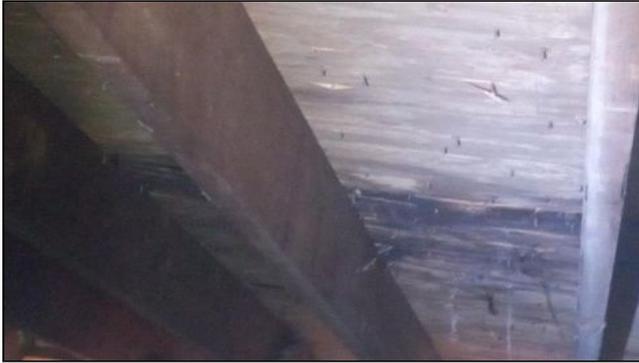
2.7.B Item 3 (Picture)

Stains observed in the garage attic . Stain tested dry with a moisture meter at time of inspection. Recommend further review and repairs as needed.

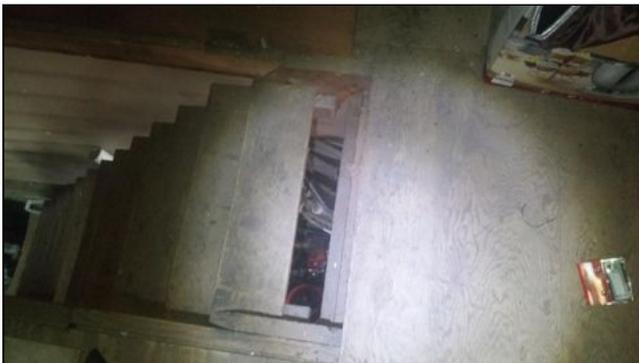
2.9.B Item 1 (Picture)

Spacing between open risers at detached garage are greater than 4 inches on stair unit that is *30 inches or higher*. This is considered improper as a 4 inch sphere can penetrate. And there are missing and damaged boards. Recommend repairs / replacement as necessary to ensure safety.

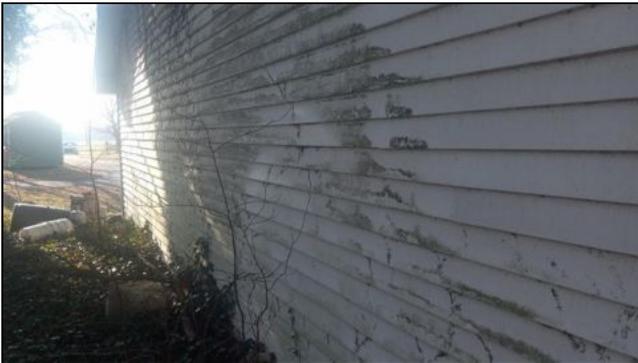
2.11.B Item 1 (Picture)

Vinyl siding is weathered. Recommend washing / pressure washing to clean.

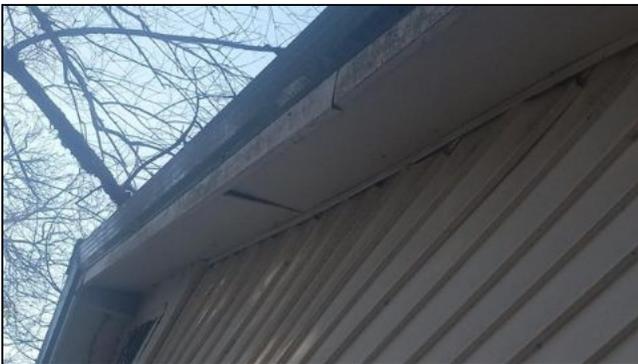
2.12.B Item 1 (Picture)

Loose / missing trim pieces observed at detached garage . Recommend repair / replacement as necessary.

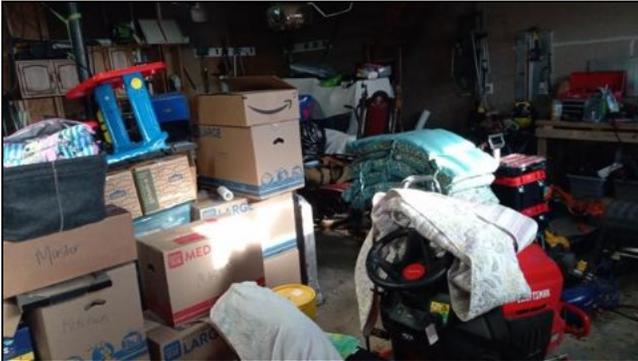
2.16.B Item 1 (Picture)

Limited review of the garage due to personal property.

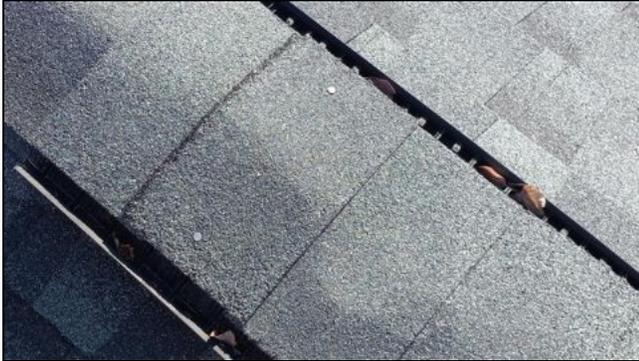
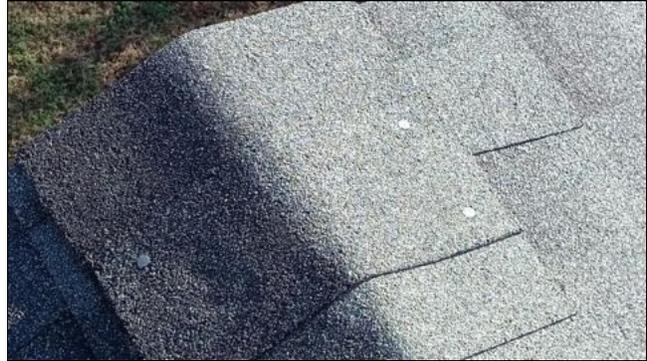
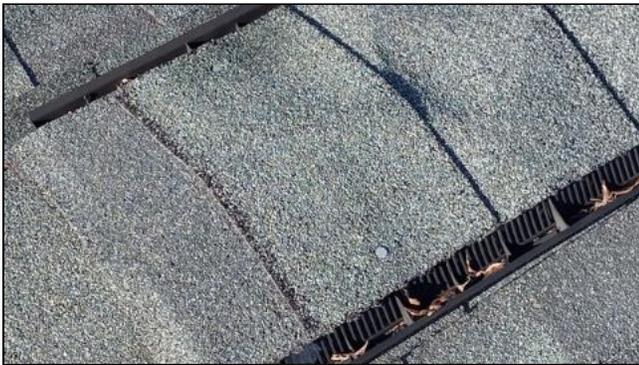
**Comments:****3.0 (1) Roof Conditions: Maintenance / Monitor:**

Nails are not sealed at cap shingles at Ridge Vent. Nail heads should be sealed to prevent water penetration as a part of routine maintenance.

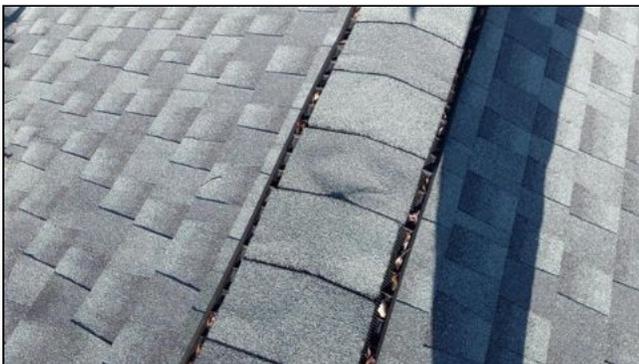
3.0 Item 4 (Picture)

Ridge cap shingle dented/flattened in areas. Recommend repair of these shingles for proper water runoff.

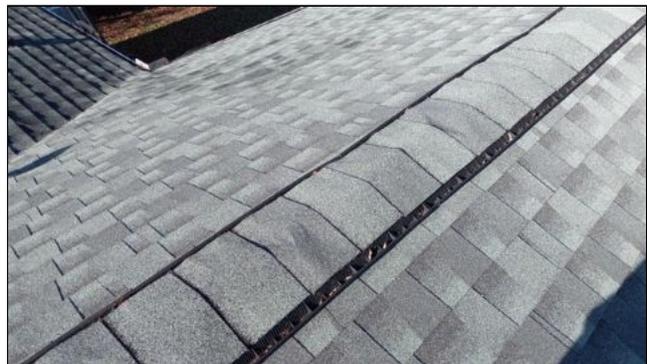
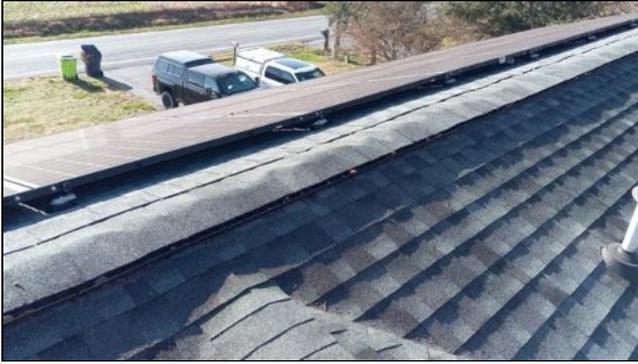
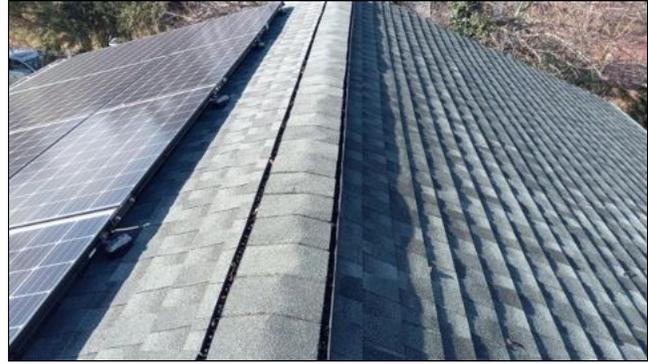
**3.0 (2) Roof Conditions: Maintenance / Monitor:**

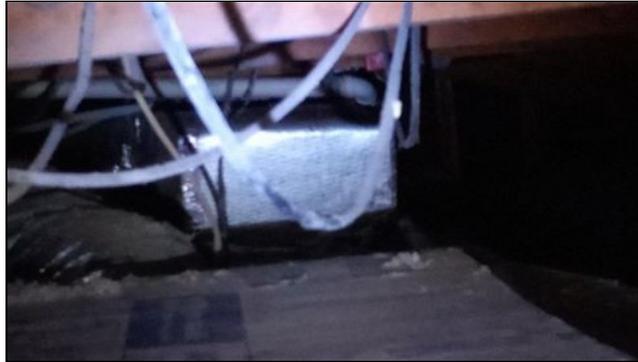
5.8 Item 1 (Picture)

### 5.8 Attic Comments: **Upgrade:**

There is an old abandoned Air handler in the attic. Recommend removing old system and components.

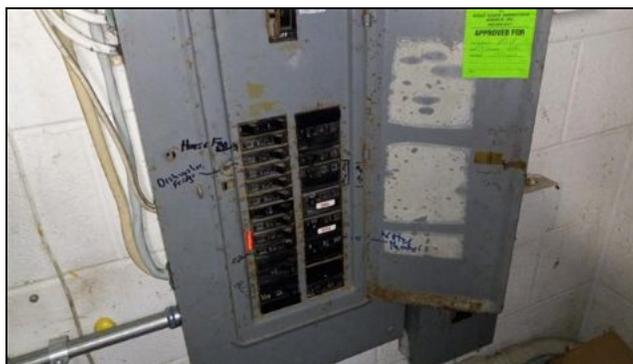
9.2 Item 1 (Picture)

**9.2 (1) Main Panel Condition:**

**Upgrade:**

Some labels are present, but are illegible or confusing. Recommend correcting for safety.

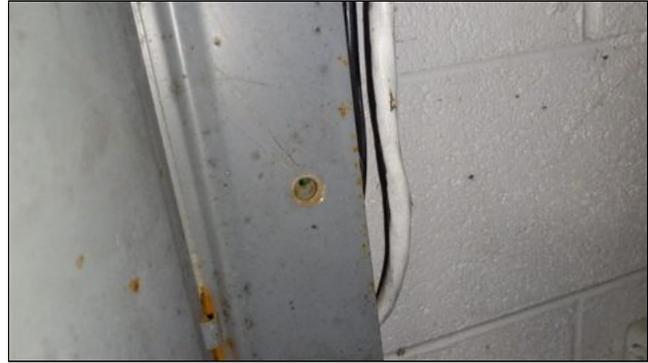
**9.2 (2) Main Panel Condition: Maintenance / Monitor:**

Missing panel screws were noted in the main panel. Recommend that a qualified electrician secure the panel cover with the appropriate type screws, to help assure safety and serviceability.

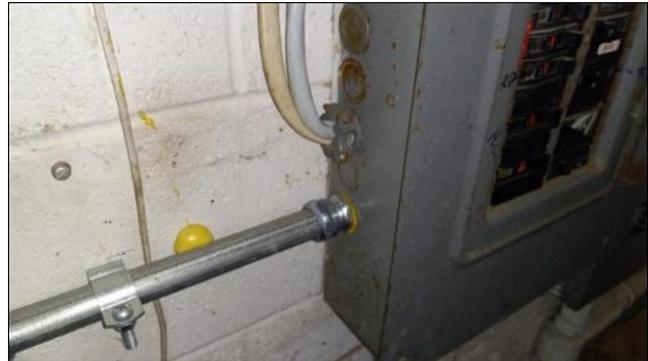
**9.2 (3) Main Panel Condition: Major Defect:**

Electric panel is mounted directly onto foundation wall without wood spacer which is considered improper. Wood is recommended to be between the foundation wall and the panel box.

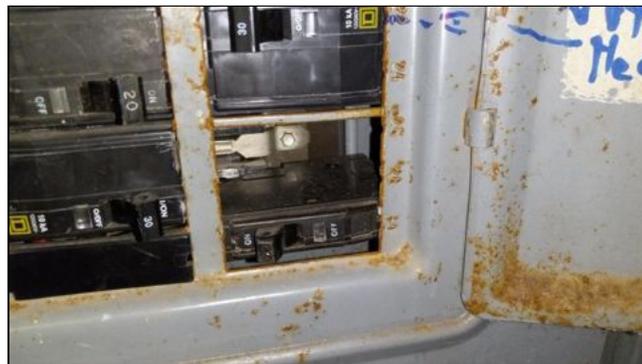
9.2 Item 6 (Picture)

Open knockouts observed in the main panel cover. Recommend installing knockout plugs, as needed, for safety.

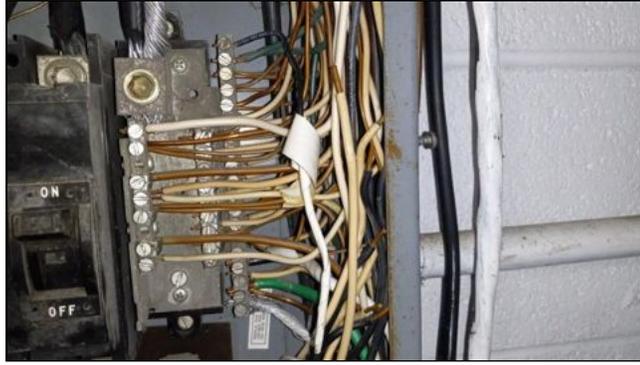
9.2 Item 7 (Picture)

Doubled up neutrals and grounds were observed in the main panel. The connection of a neutral and equipment-grounding conductor is no longer allowed by today's standards. One of the objectives of a correct arrangement of bonding jumpers, neutrals and equipment grounds is to allow circuit isolation while keeping the equipment grounding conductor still connected to the grounding electrode. A licensed electrician is recommended to review the panel and make all corrections necessary for safe and proper operation of the system.

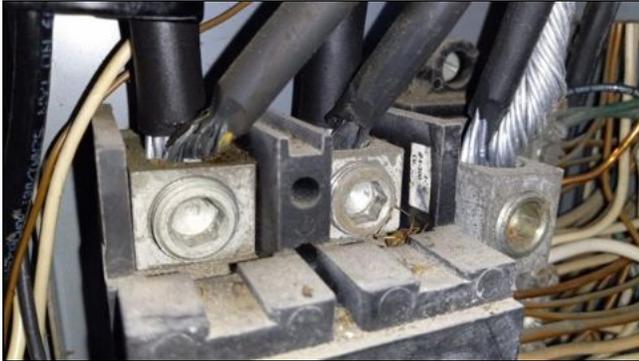
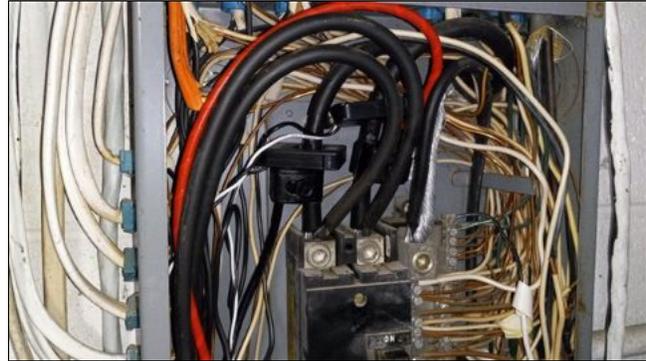
**9.2 (6) Main Panel Condition: Major Defect:**

Double tapping observed in the main panel. The 100 amp service for the detached garage is double tapped into the 150 amp service lugs. Double tapping (i.e. 2 wires on a single pole breaker) can add to the load of the affected circuit causing a possible overload and tripping breakers. Recommend repair / replacement as necessary.

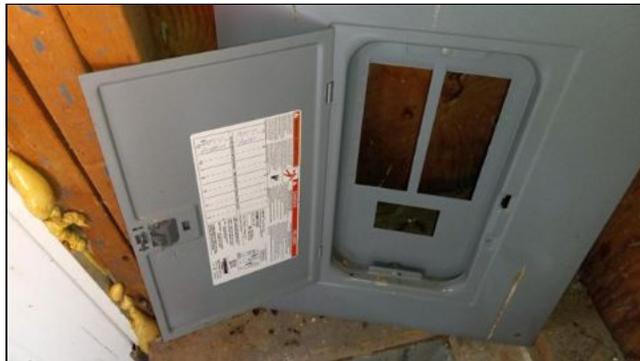
9.3 Item 1 (Picture)

**9.3 Sub Panel Condition: Major Defect:**

The electrical inspection sticker is missing.

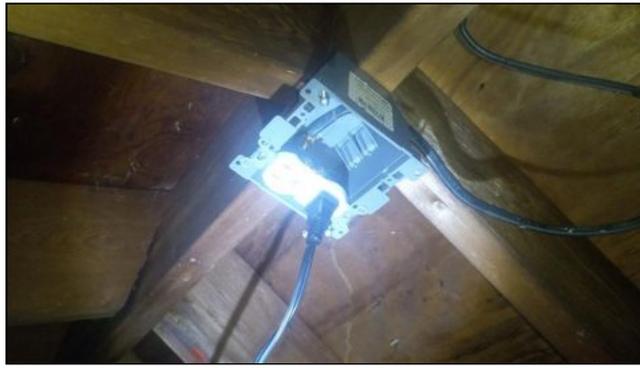
9.9 Item 1 (Picture)

Receptacle cover is missing at garage attic. Recommend replacing to ensure safety.

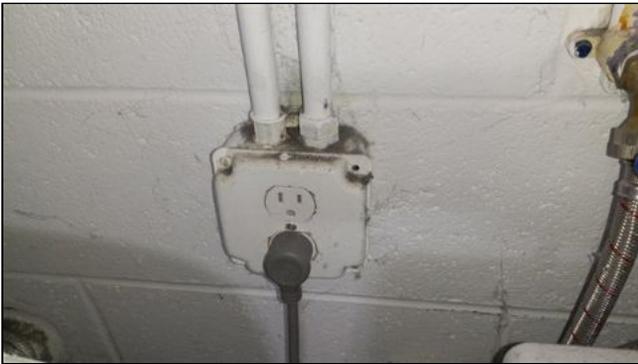
9.9 Item 2 (Picture)

Outlet is mounted directly onto foundation wall without a wood spacer at laundry room and garage which is considered improper. Wood is recommended to be between the foundation wall and the outlet to ensure safety.

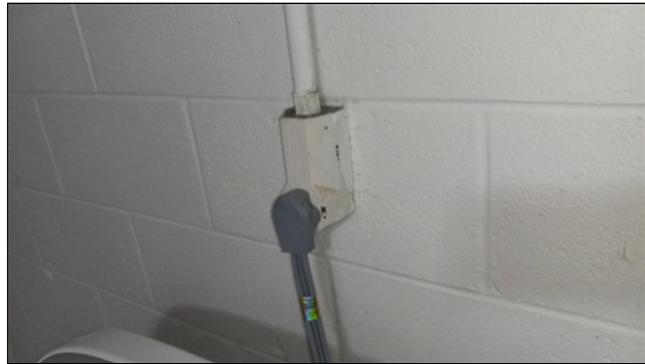
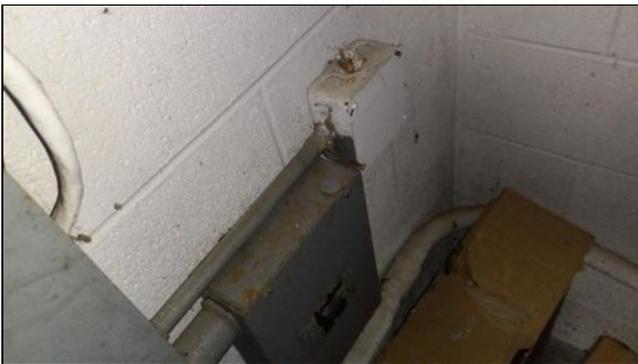
**9.9 (1) Outlets: Major Defect:**

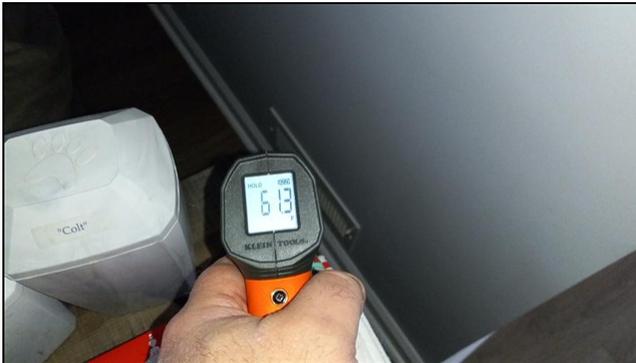
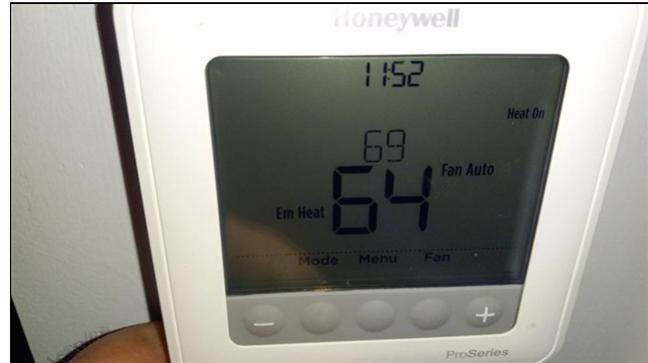
**10.1.A (1) Operation / Temp Readings: Major Defect:**

The emergency back up heat was tested and found NOT to be serviceable with a supply temperature of 61 degrees which is NOT within the normal operating range of 90 - 120 degrees.

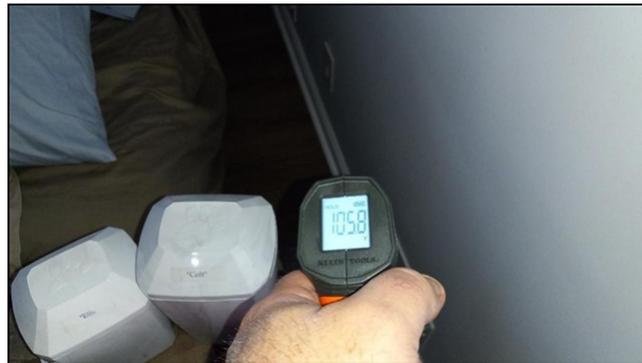
10.1.A Item 3 (Picture)

The furnace was tested using normal operating controls and supplied a temperature of 105 degrees in heat mode. Due to inaccessibility of many of the components of this unit, the review is limited. Unit was operated by the thermostat. As with all mechanical equipment the unit can fail at anytime without warning. Inspectors cannot determine future failures.

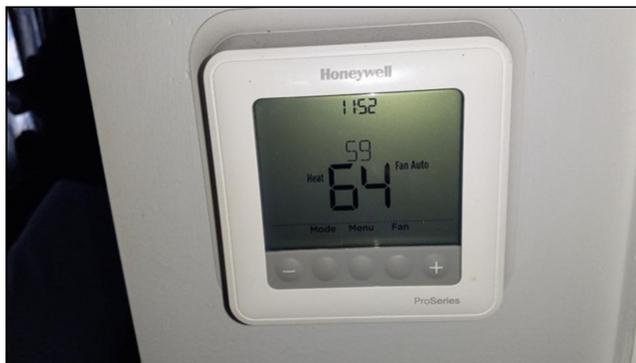
10.4.A Item 2 (Picture)

**10.4.A (2) Thermostat: NOTE:**

Upon inspectors departure thermostat was set back to heat mode and set back to 59 degrees.

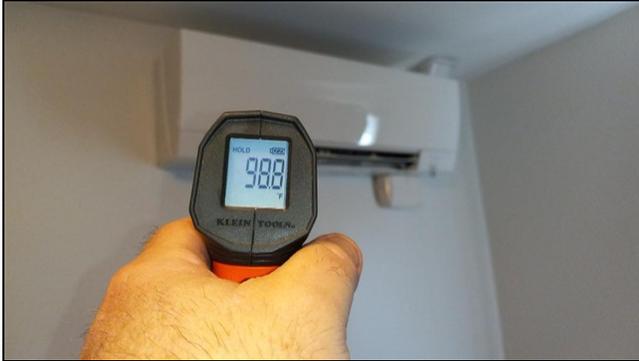
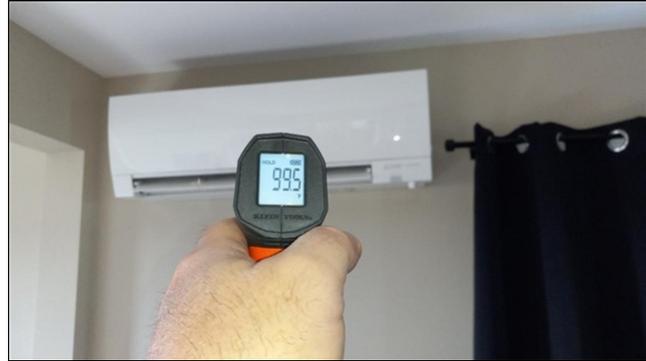
### 10.1.B Operation / Temp Readings: NOTE:

This is an electric heat pump mini split system. See air conditioning section regarding operation. Heat Mode supplied serviceable temps.

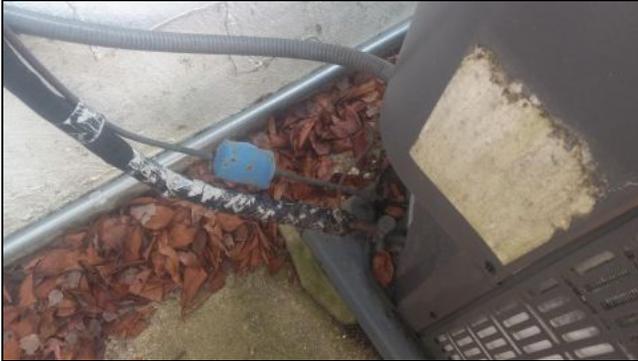
11.0.A Item 1 (Picture)

**Comments:****11.0.A (1) Cooling Equip Condition: Maintenance / Monitor:**

Damaged / Missing insulation observed on refrigerant line. Recommend correcting to prevent sweating and enhance operating efficiency.

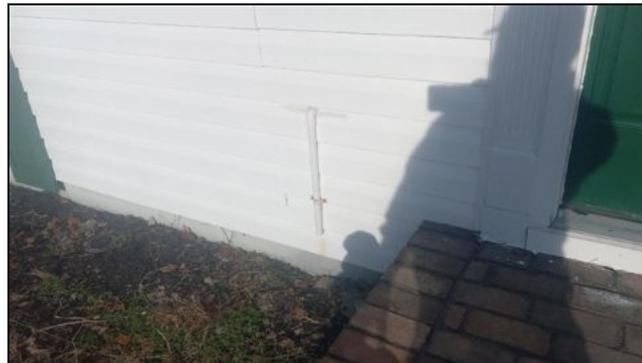
11.1.A Item 1 (Picture)

Air conditioning condensate drain line discharges too close to foundation. Recommend discharging away from foundation to prevent foundation moisture penetration.

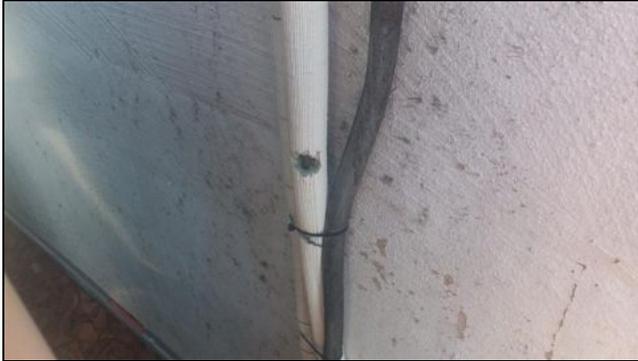
11.0.B Item 1 (Picture)

### 11.0.B (1) Cooling Equip Condition: **Maintenance / Monitor:**

Damaged / Missing insulation observed on refrigerant line. Recommend correcting to prevent sweating and enhance operating efficiency.

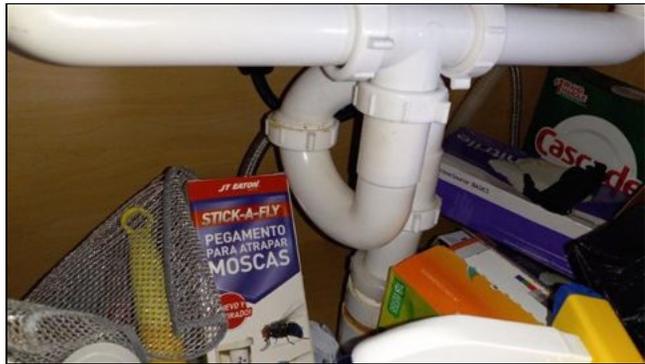
12.1 Item 1 (Picture)

**12.1 Sinks: Upgrade:**

S trap present at kitchen. While common practice at time of construction, they tend to siphon dry easily and are discouraged from use. Client may want to consider improving trap configuration.
