## Home Inspection Report

Prepared for: Archie c/o James Riddle  
Inspection #: 202512-62329  
Inspection Address: 3231 Williamsville Road,  
Houston DE 19954

Inspection Company: **Amerispec**  
Office: 302-996-0405  
Inspector: Rob Graves Lic # DE H4-0010208

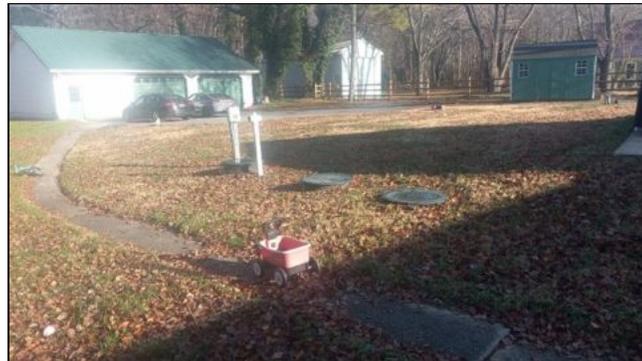
12.4 Item 1 (Picture)

Waste disposal system appears to be private on-site waste disposal. Septic tanks, leach fields and other private sewage systems are outside the scope of this report and are not inspected. Recommend review by a qualified professional to assess the functionality and condition of this system.

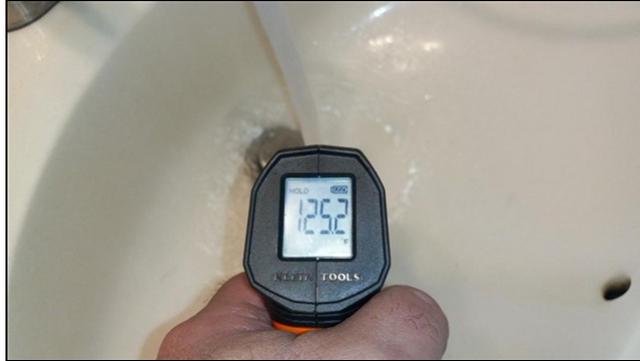
13.1 Item 1 (Picture)

The water temperature at time of inspection was 125 degrees.

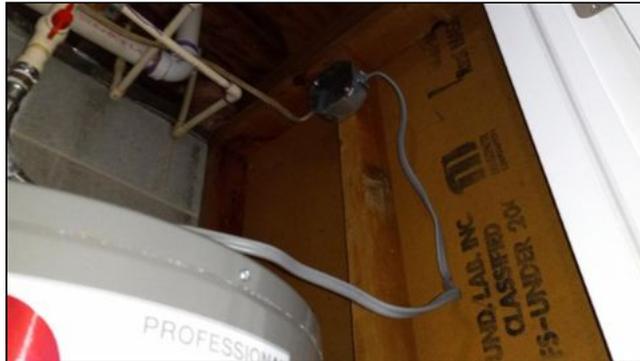
13.2 Item 1 (Picture)

### 13.2 Energy Source: **Upgrade:**

No electric disconnect observed at water heater. Suggest installation of an electric disconnect to enhance safety.

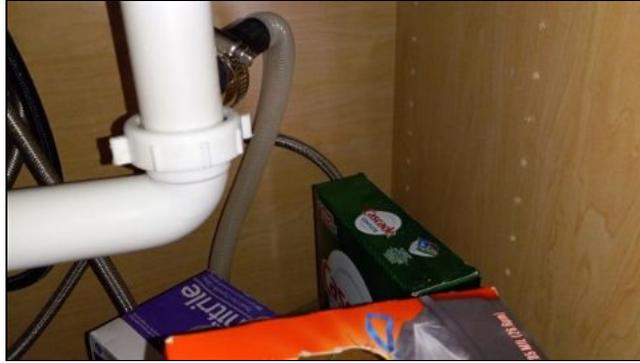
14.2 Item 1 (Picture)

**Comments:****14.2 Dishwasher: Upgrade:**

Drain line air gap is not installed properly. An air gap assists in positive drainage, acting to prevent clogging as well as serving to prevent back siphoning in the event the sink drain line becomes clogged. The drain hose should be raised so it passes 6 inches above the elevation at which it empties into the disposal or main drain line

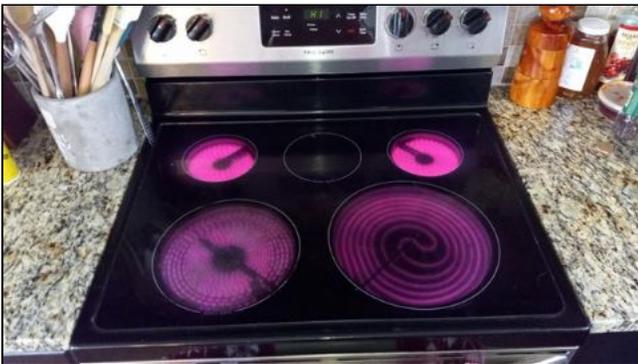
14.3 Item 1 (Picture)

**NOTE:** The electrical stove/range elements were tested at the time of inspection and appeared to function properly. These can fail at anytime without warning. No warranty, guarantee, or certification is given as to future failure.

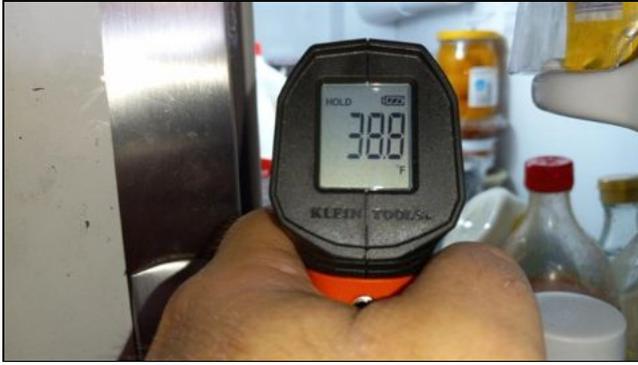
14.6 Item 1 (Picture)

below 40 degrees fahrenheit and the freezer at or below 0 degrees. The refrigerator supplied temperature at 38 degrees and the freezer at 0 degrees.

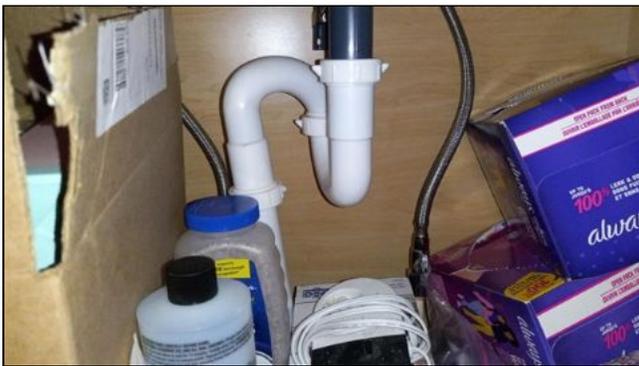
15.1 Item 1 (Picture)

### 15.1 Sinks: Upgrade:

S trap present at the master bathroom. While common practice at time of construction, they tend to siphon dry easily and are discouraged from use. Client may want to consider improving trap configuration.

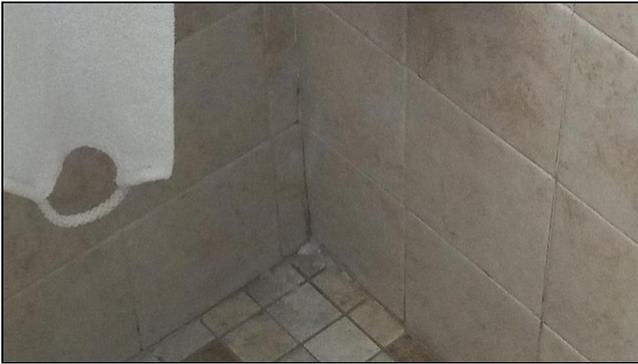
15.3 Item 1 (Picture)

Openings in grout/caulk observed in the master bathroom. Any openings to include edges of the tub/shower surrounds and spouts should be caulked to prevent moisture penetration. Failure to keep these areas sealed can cause deterioration and moisture damage to the interior walls, which is not always visible to the inspector at the time of inspection.

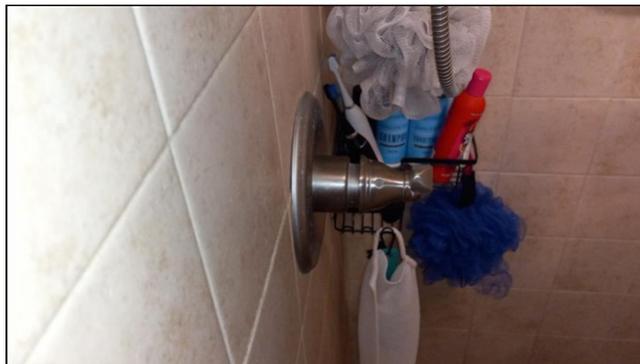
15.3 Item 4 (Picture)

The master bathroom faucet is loose at wall. Recommend review by a licensed plumber for repair or replacement, as necessary, prior to close.

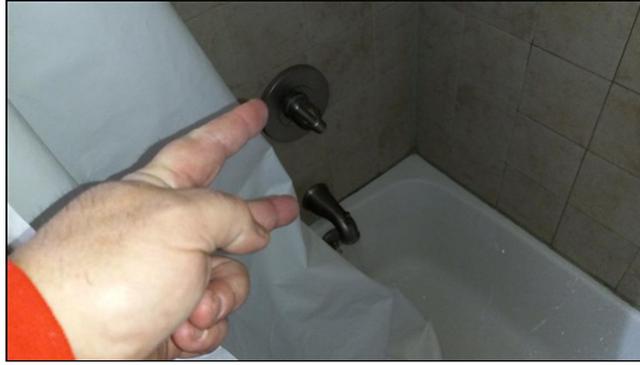
15.3 Item 5 (Picture)

The hall bathroom faucet is loose at wall. Recommend review by a licensed plumber for repair or replacement, as necessary, prior to close.

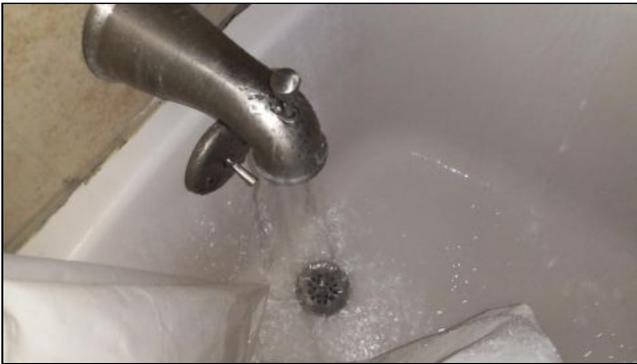
15.3 Item 6 (Picture)

Shower diverter in the hall bathroom does not fully engage. This is common. Client may want to consider repair / replacement if condition becomes significant.

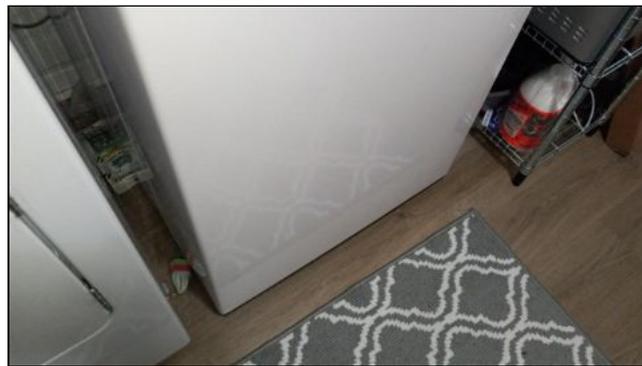
16.0 Item 1 (Picture)

The overflow pan is missing.  
Recommend installing as the unit is located above or within living space

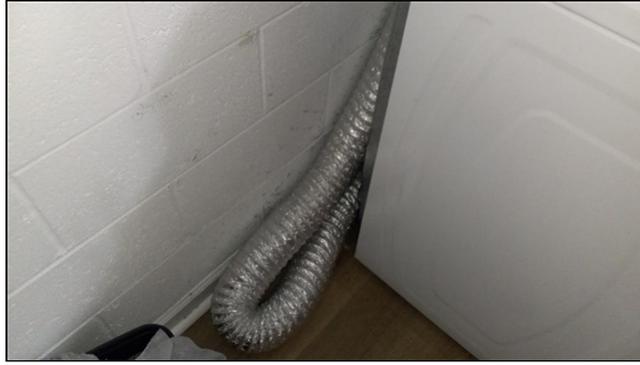
16.2 Item 1 (Picture)

Dryer vent material is foil type, recommend replacing with smooth metal vent pipe upon taking ownership as this is considered a potential fire hazard. As a safety measure, we recommend replacing this exhaust hose with an approved metallic dryer vent duct.

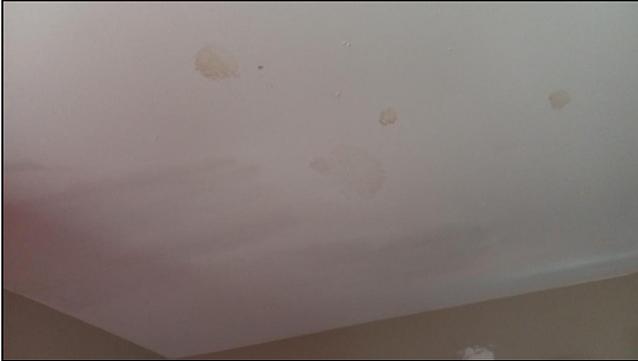
17.2 Item 1 (Picture)

**Comments:****17.2 (1) Ceilings: Major Defect:**

Stains observed in the master bedroom . Stain tested dry with a moisture meter at time of inspection. Recommend further review and repairs as needed.

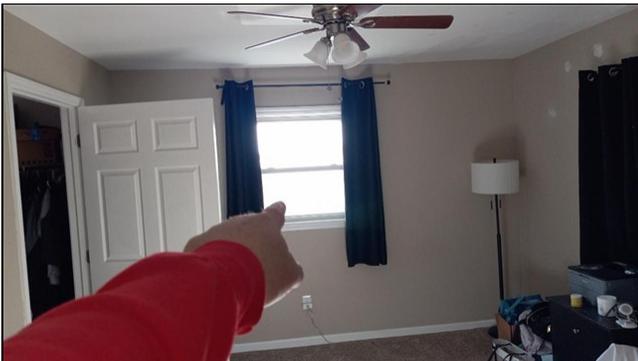
17.4 Item 1 (Picture)

**17.4 (1) Windows: Major Defect:**

Observed both sash wires/cords broken at master bedroom . This is a "Safety Concern". Sash wire/cord holds window in open position. Suggest repairs / replacement as needed to ensure safety.
