Home Inspection Report

Prepared for: James Riddle
Inspection #: 202506-61052
Inspection Address: 1113 Kayla Lane
Townsend DE 19734

Inspection Company: **Amerispec**
Office: 302-996-0405
Inspector: Clay Ballard Lic # DE H4-0010250

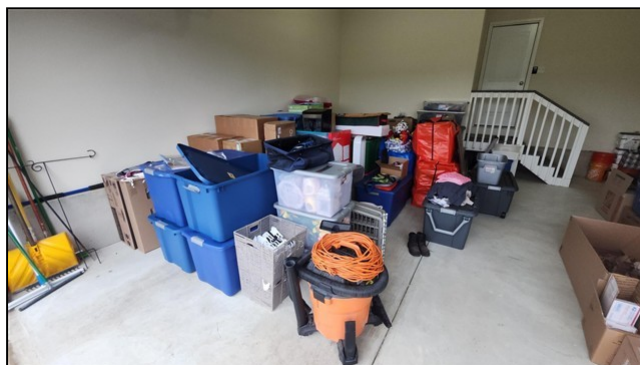
2.8 Item 1 (Picture)

Confirm:

Limited review of the garage due to personal property.

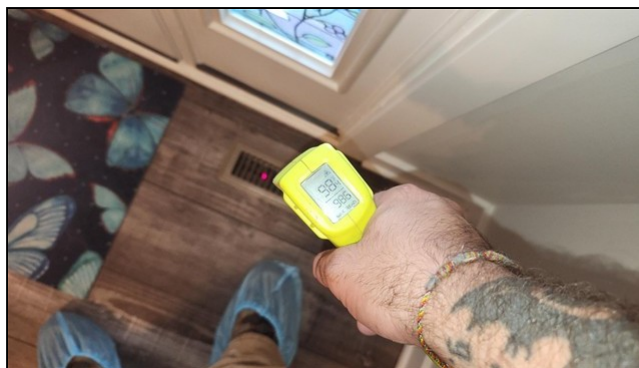
7.1 Item 1 (Picture)

The furnace was tested using normal operating controls and supplied a temperature of 98 degrees. Due to inaccessibility of many of the components of this unit, the review is limited. Holes or cracks in the heat exchanger are not within the scope of this inspection as heat exchangers are not visible or accessible to the inspector. Unit was operated by the thermostat. As with all mechanical equipment the unit can fail at anytime without warning. Inspectors cannot determine future failures.

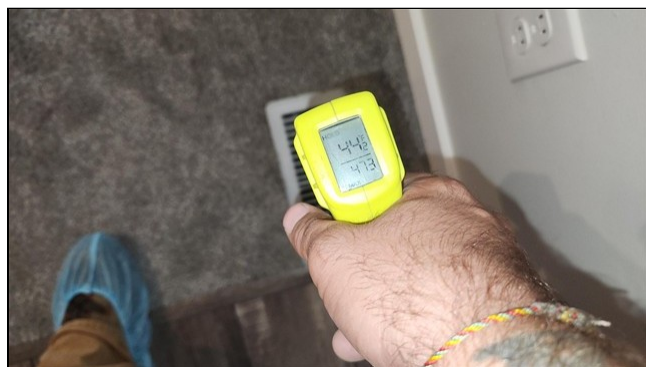
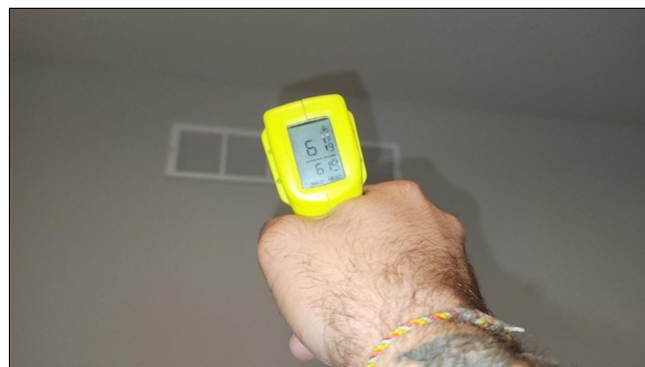
8.2 Operation / Temp Readings: NOTE:

Unit was tested and was serviceable at time of inspection. A temperature drop was performed across the evaporator coil of this unit. When tested, temperature at supply register was 44 degrees, temperature at return was 61 degrees, which is a difference of 17 degrees which is within the 14 to 22 degree normal operating range.

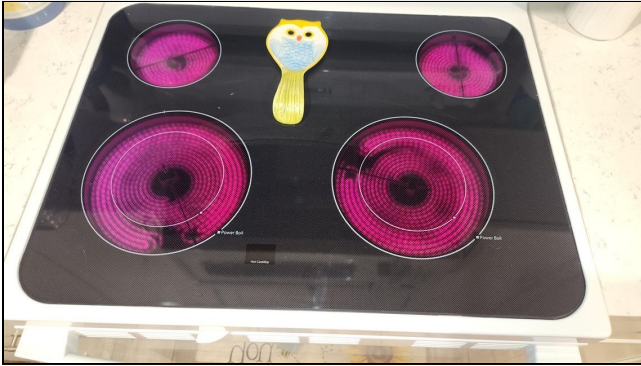
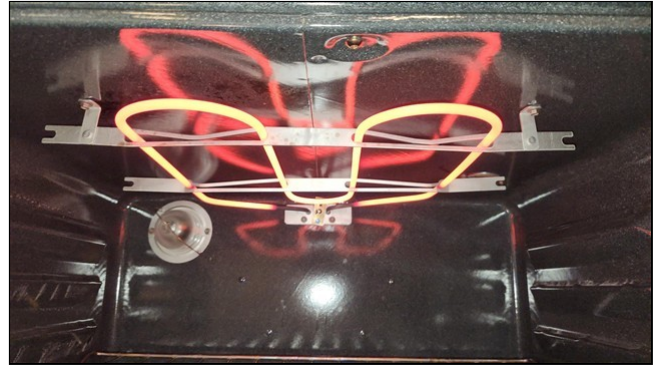
11.3 Ranges/Ovens/Cooktops:

NOTE: The electrical stove/range elements were tested at the time of inspection and appeared to function properly. These can fail at anytime without warning. No warranty, guarantee, or certification is given as to future failure.

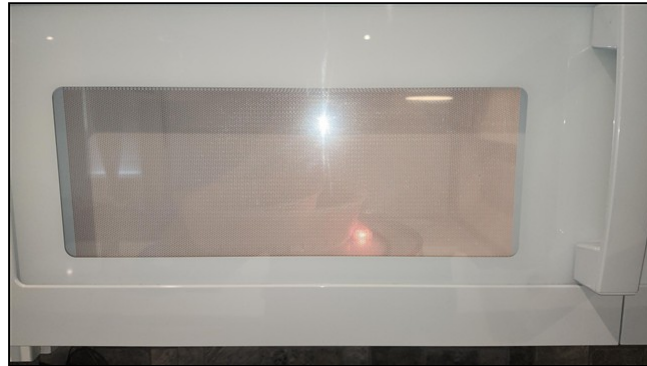
11.5 Item 1 (Picture)

11.5 Microwave: NOTE:

Built-in microwave ovens are tested using normal operating controls. Unit was tested and was serviceable at time of inspection. Leak and/or efficiency testing is beyond the scope of this inspection.

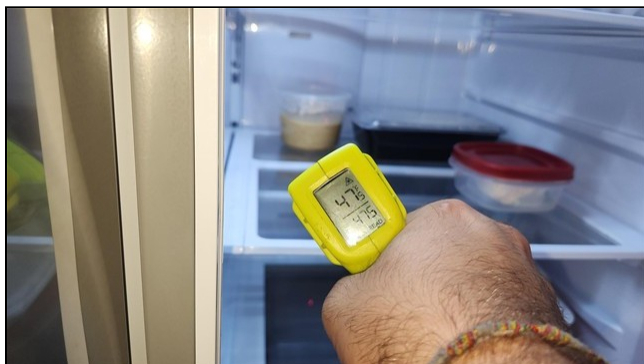
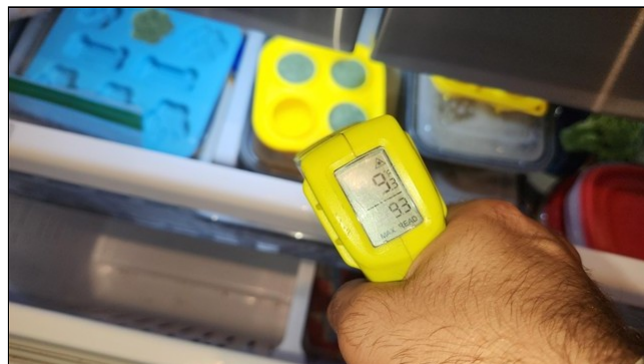
11.6 Refrigerator: NOTE:

The refrigerator/freezer, freon levels, icemaker operation and other specialty items are beyond the scope of inspection. A temperature reading **ONLY** was taken for your information only. The refrigerator should be kept at or below 40 degrees fahrenheit and the freezer at or below 0 degrees. The refrigerator supplied temperature at 47 degrees and the freezer at 9 degrees.

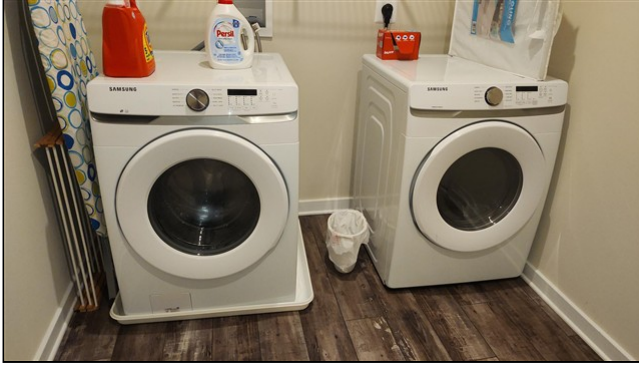
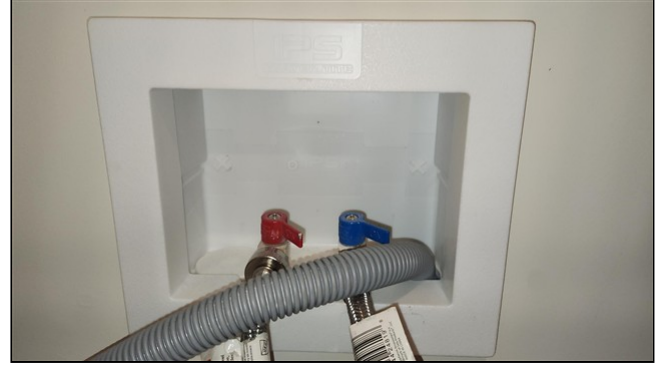
13. Washer / Dryer

Dryer vent material is foil type, recommend replacing with smooth metal vent pipe upon taking ownership as this is considered a potential fire hazard. As a safety measure, we recommend replacing this exhaust hose with an approved metallic dryer vent duct.
